TECHNICAL MEMO

September 29, 2023File:117085-4Ryan Tucker, Township of Woolwich,Matt Scott, P.Eng.Middlebrook Place Bridges MCEAStructure 180160, 2023 Review and Revised CostEstimates

LIMITED CONDITION SURVEY REPORT

Site 180160, Middlebrook Truss West Montrose, ON

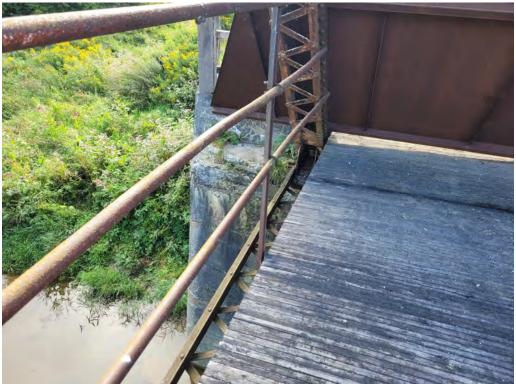
- The existing bridge deck shows moderate to severe weathering, checking, splitting and rot. Refer to Photograph 1.
- Steel stringers in the end bays (Bays 1 and 9) have completely failed and crushed at abutments, leading to settlements of the deck. Refer to Photographs 2, 3, 4 and 5. The wood deck has partially lost contact with the stringer top flanges near the east abutment.

Photograph 1: Deck at east abutment, north truss. Note weathering of deck and triangular daylight below steel barricade wall indicating settlement of deck towards north truss.

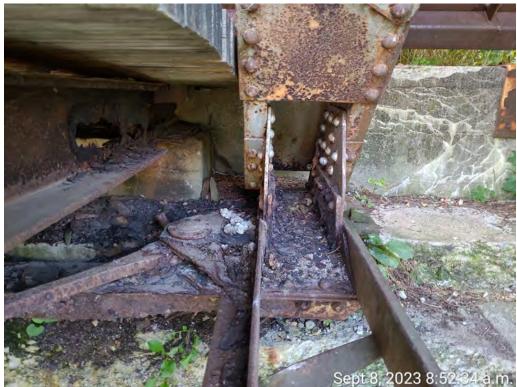
Photograph 2: Stringer in Bay 1 and east abutment, south bearing. Note complete loss of section in stringer web and loss of contact between wood deck and stringer top flange.

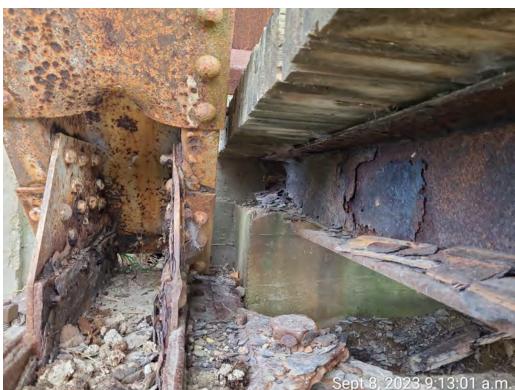
Photograph 3: Stringer in Bay 9 and west abutment, south bearing. Note complete loss of section in stringer bottom flange at stringer bearing seat, severe corrosion of bearing plates and severe corrosion of bottom lateral.

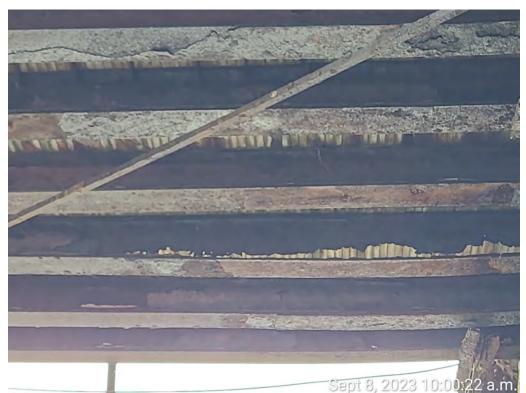
Photograph 4: Stringers in Bay 1 looking north. Note complete loss of section in stringer webs.

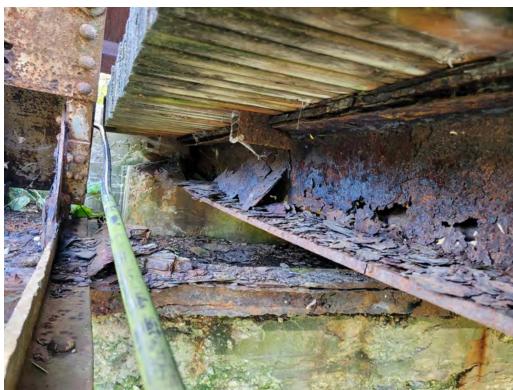
Photograph 5: Stringer in Bay 1 and east abutment, north bearing. Note complete loss of section in stringer web, corrosion in stringer top flange, severe corrosion of bottom lateral and loss of section of stringer flange at stringer bearing seat.

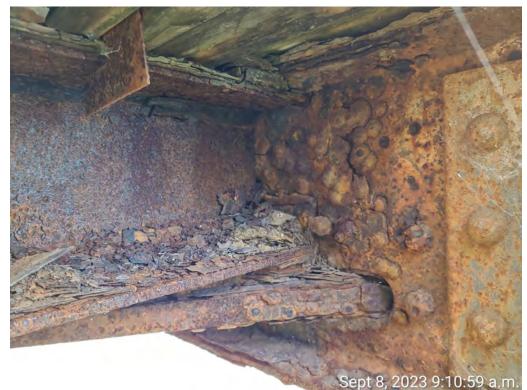
Photograph 6: Bay 9 stringer at east end showing bearing support angle severe corrosion, severe corrosion of floor beam and severe corrosion of bottom lateral.

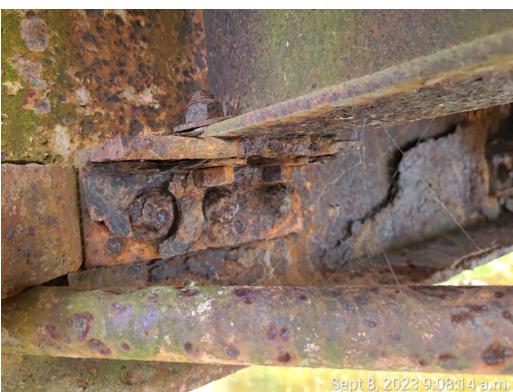
Photograph 7: Bay 8 stringer at west end showing severe corrosion of floor beam and severe corrosion of stringer bearing support angle.

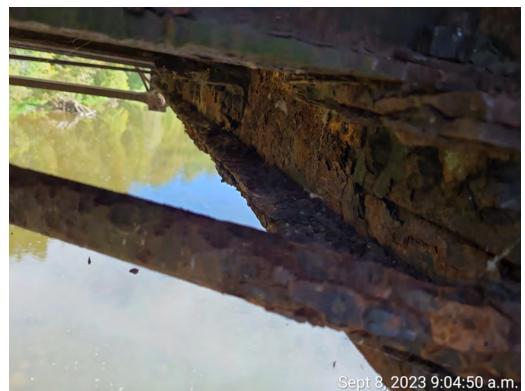
Photograph 8: Bay 8, east end showing severe corrosion of bottom lateral and floor beam.

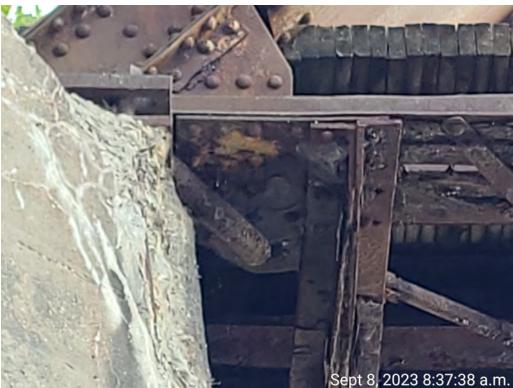
Top Laterals	N/A	Replacement of loose top laterals may be required. Further investigation is required.
Bearings	Replace 4 each	Roller bearings at west abutment have failed. Roller pins are visibly dislodged at southwest bearing. Replacement of fixed bearings at east abutment at same time as roller bearings is recommended.

Photograph 9: West abutment, south bearing showing dislodged bearing roller pin.

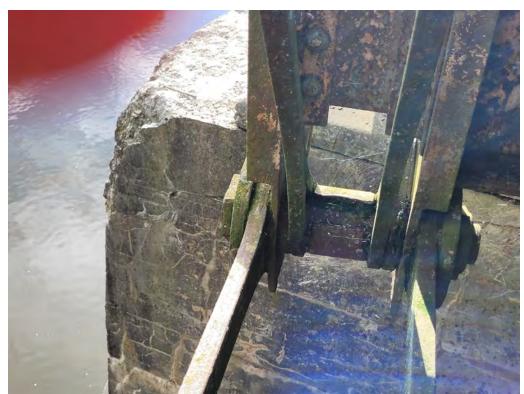
- The bottom chord pin joints show signs of light to severe section loss in the diagonal eye bars and vertical web plates, as well as isolated impact damage to the bottom chord eye bars. Refer to Photographs 10, 11 and 12. The exterior bottom chord at Joint 6 of the north truss appears to have a crack in the top face of the eye bar as shown in Photograph 10.

Photograph 10: North truss, Joint 6 showing light to severe corrosion of eye bars and vertical web plates as well as crack in bottom exterior chord.

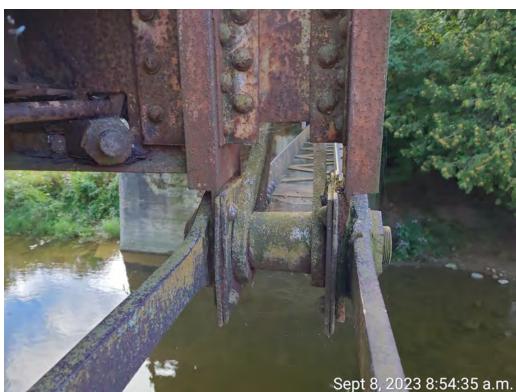
Photograph 11: South truss, Joint 3 showing medium corrosion of vertical web plates and gouge in exterior bottom chord.

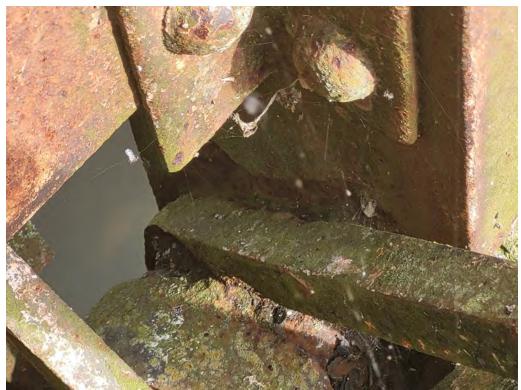
Photograph 12: North truss, Joint 4 showing section loss at diagonal eye bar and vertical web plate.

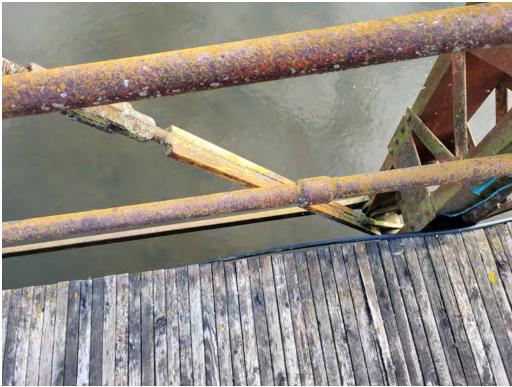
- The counter diagonal in the north truss, Bay 4 has a previous repair at the bottom chord connection. Refer to Photograph 13.
- The bottom chords in Bay 9 of each truss have a previous repair between the original bottom chord angles and lacing bars. Refer to Photograph 14.

Photograph 13: North truss, Bay 4 counter diagonal showing previous repair of square bars welded to eye bar (date of repair unknown).

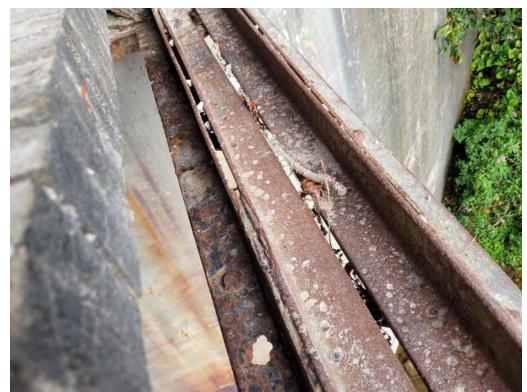
Photograph 14: North truss, Bay 9 bottom chord showing previous repair of angles welded between original bottom chord angles and lacing bars (date of repair unknown).

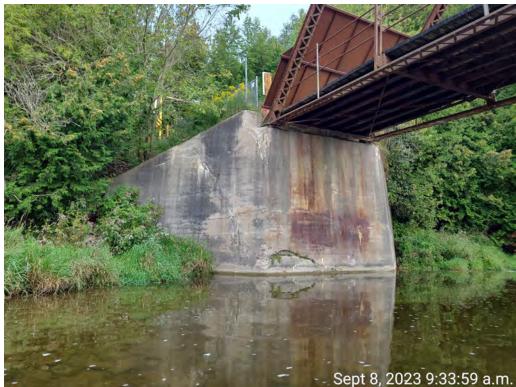
- The west abutment and wingwalls show light to severe erosion, spalling and disintegration, specifically at the water line and truss bearing locations. Refer to Photograph 15.

Photograph 15: West abutment showing light to severe erosion, spalling and disintegration.

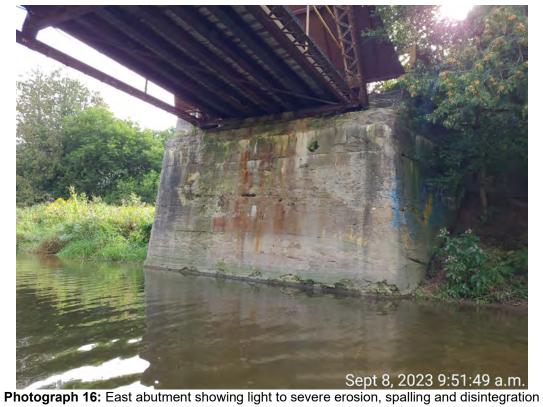
- The east abutment and wingwalls show light to severe erosion, spalling and disintegration, and have wide vertical and horizontal cracks. A previous concrete repair to the northeast abutment footing was visible beneath the surface of the water. Refer to Photographs 16, 17 and 18.

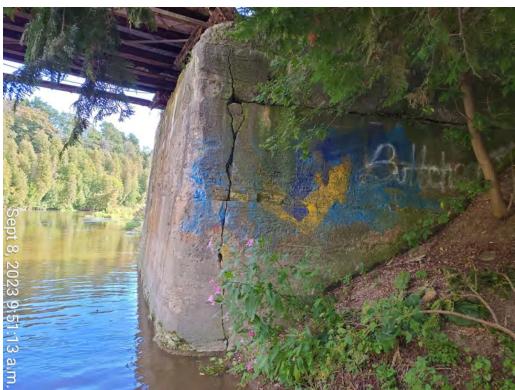
The east abutment is believed to have been constructed in approximately 1905. It is in poor condition and requires extensive rehabilitation or replacement. Of specific concern are the wide vertical cracks in each wingwall near the abutment face, which suggest that the wingwalls may be moving and/or rotating independently of the abutment. A concrete footing repair appears to have been completed at the northeast corner, which may have been to address scour and erosion or undermining of the footing. We estimate that the remaining service life of the east abutment to be approximately 10-15 years without rehabilitation.

Photograph 17: East abutment, south wingwall showing wide vertical crack at wingwall/abutment interface and wide horizontal crack at cold joint.

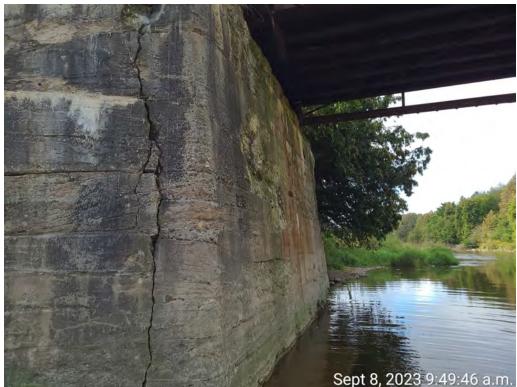
Photograph 18: East abutment, north wingwall showing wide vertical crack at wingwall/abutment interface. Footing repair visible below waterline.
