West Montrose Covered Bridge Rehabilitation

Township of Woolwich Heritage Committee Meeting

November 8, 2023

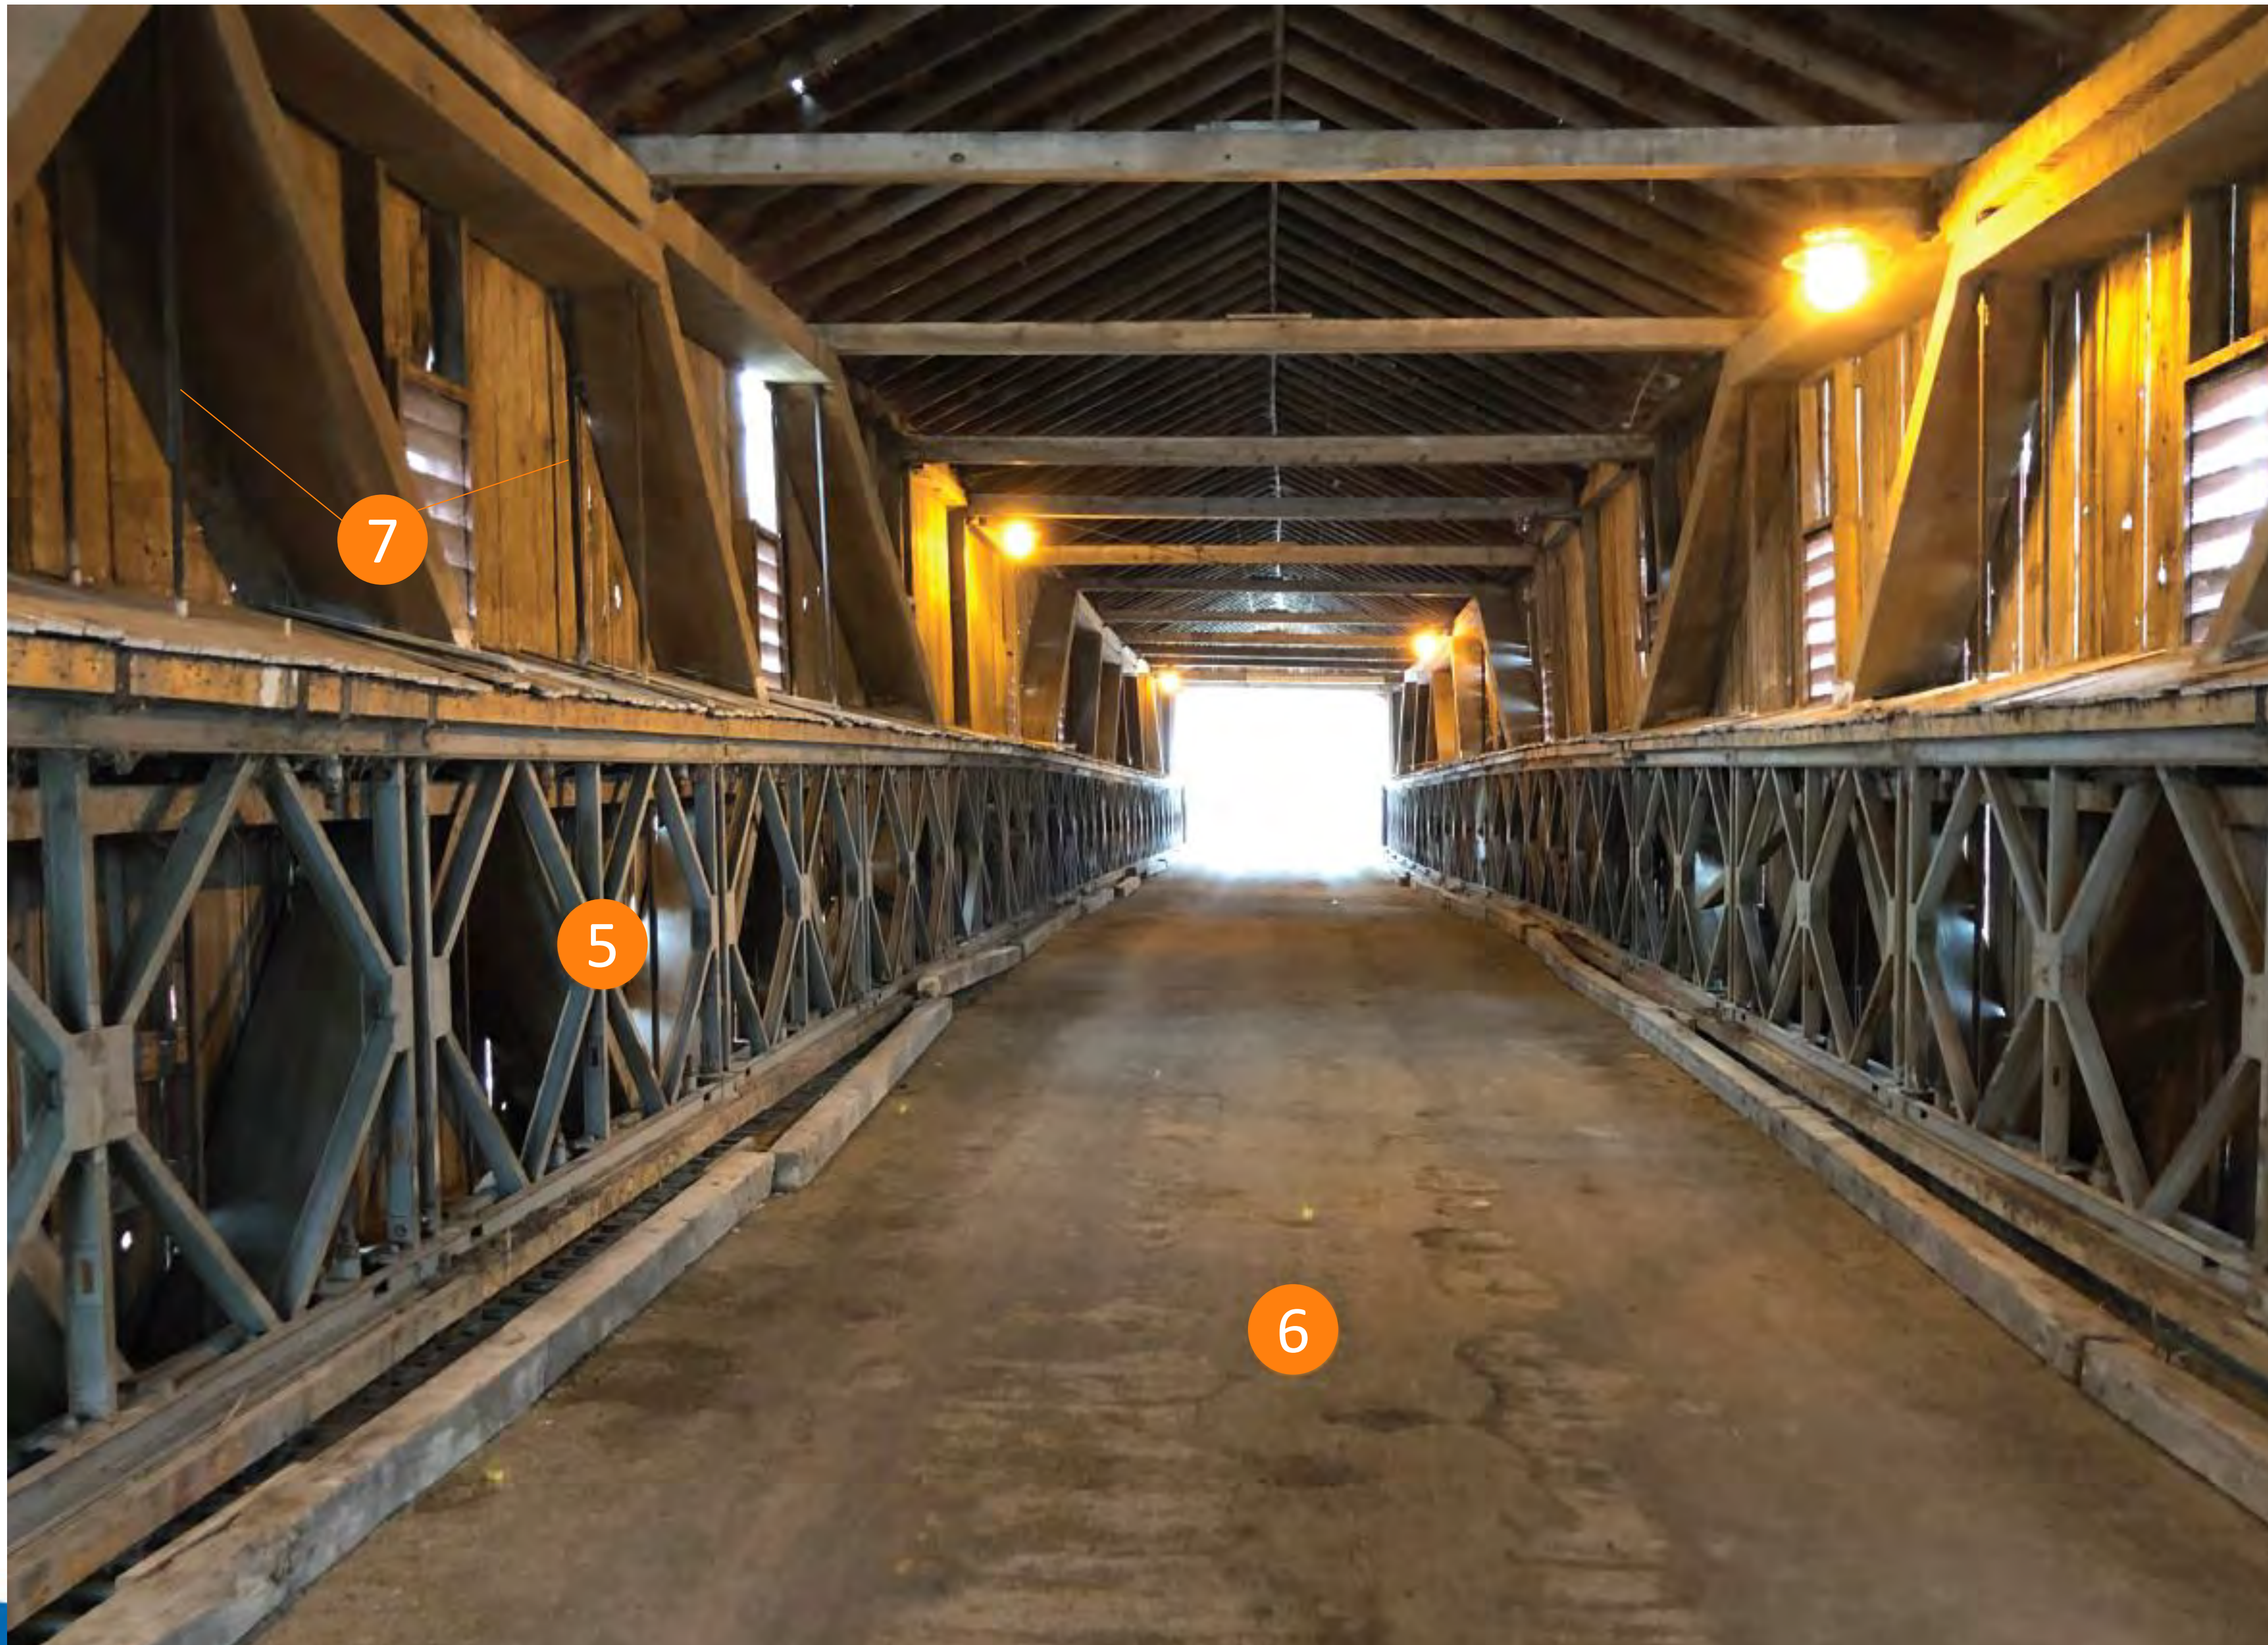
- 5 Remove steel Bailey truss
- 6 Re-instate tar and chip wearing surface after replacement of nail-laminated deck
- 7 Replace steel hanger rods

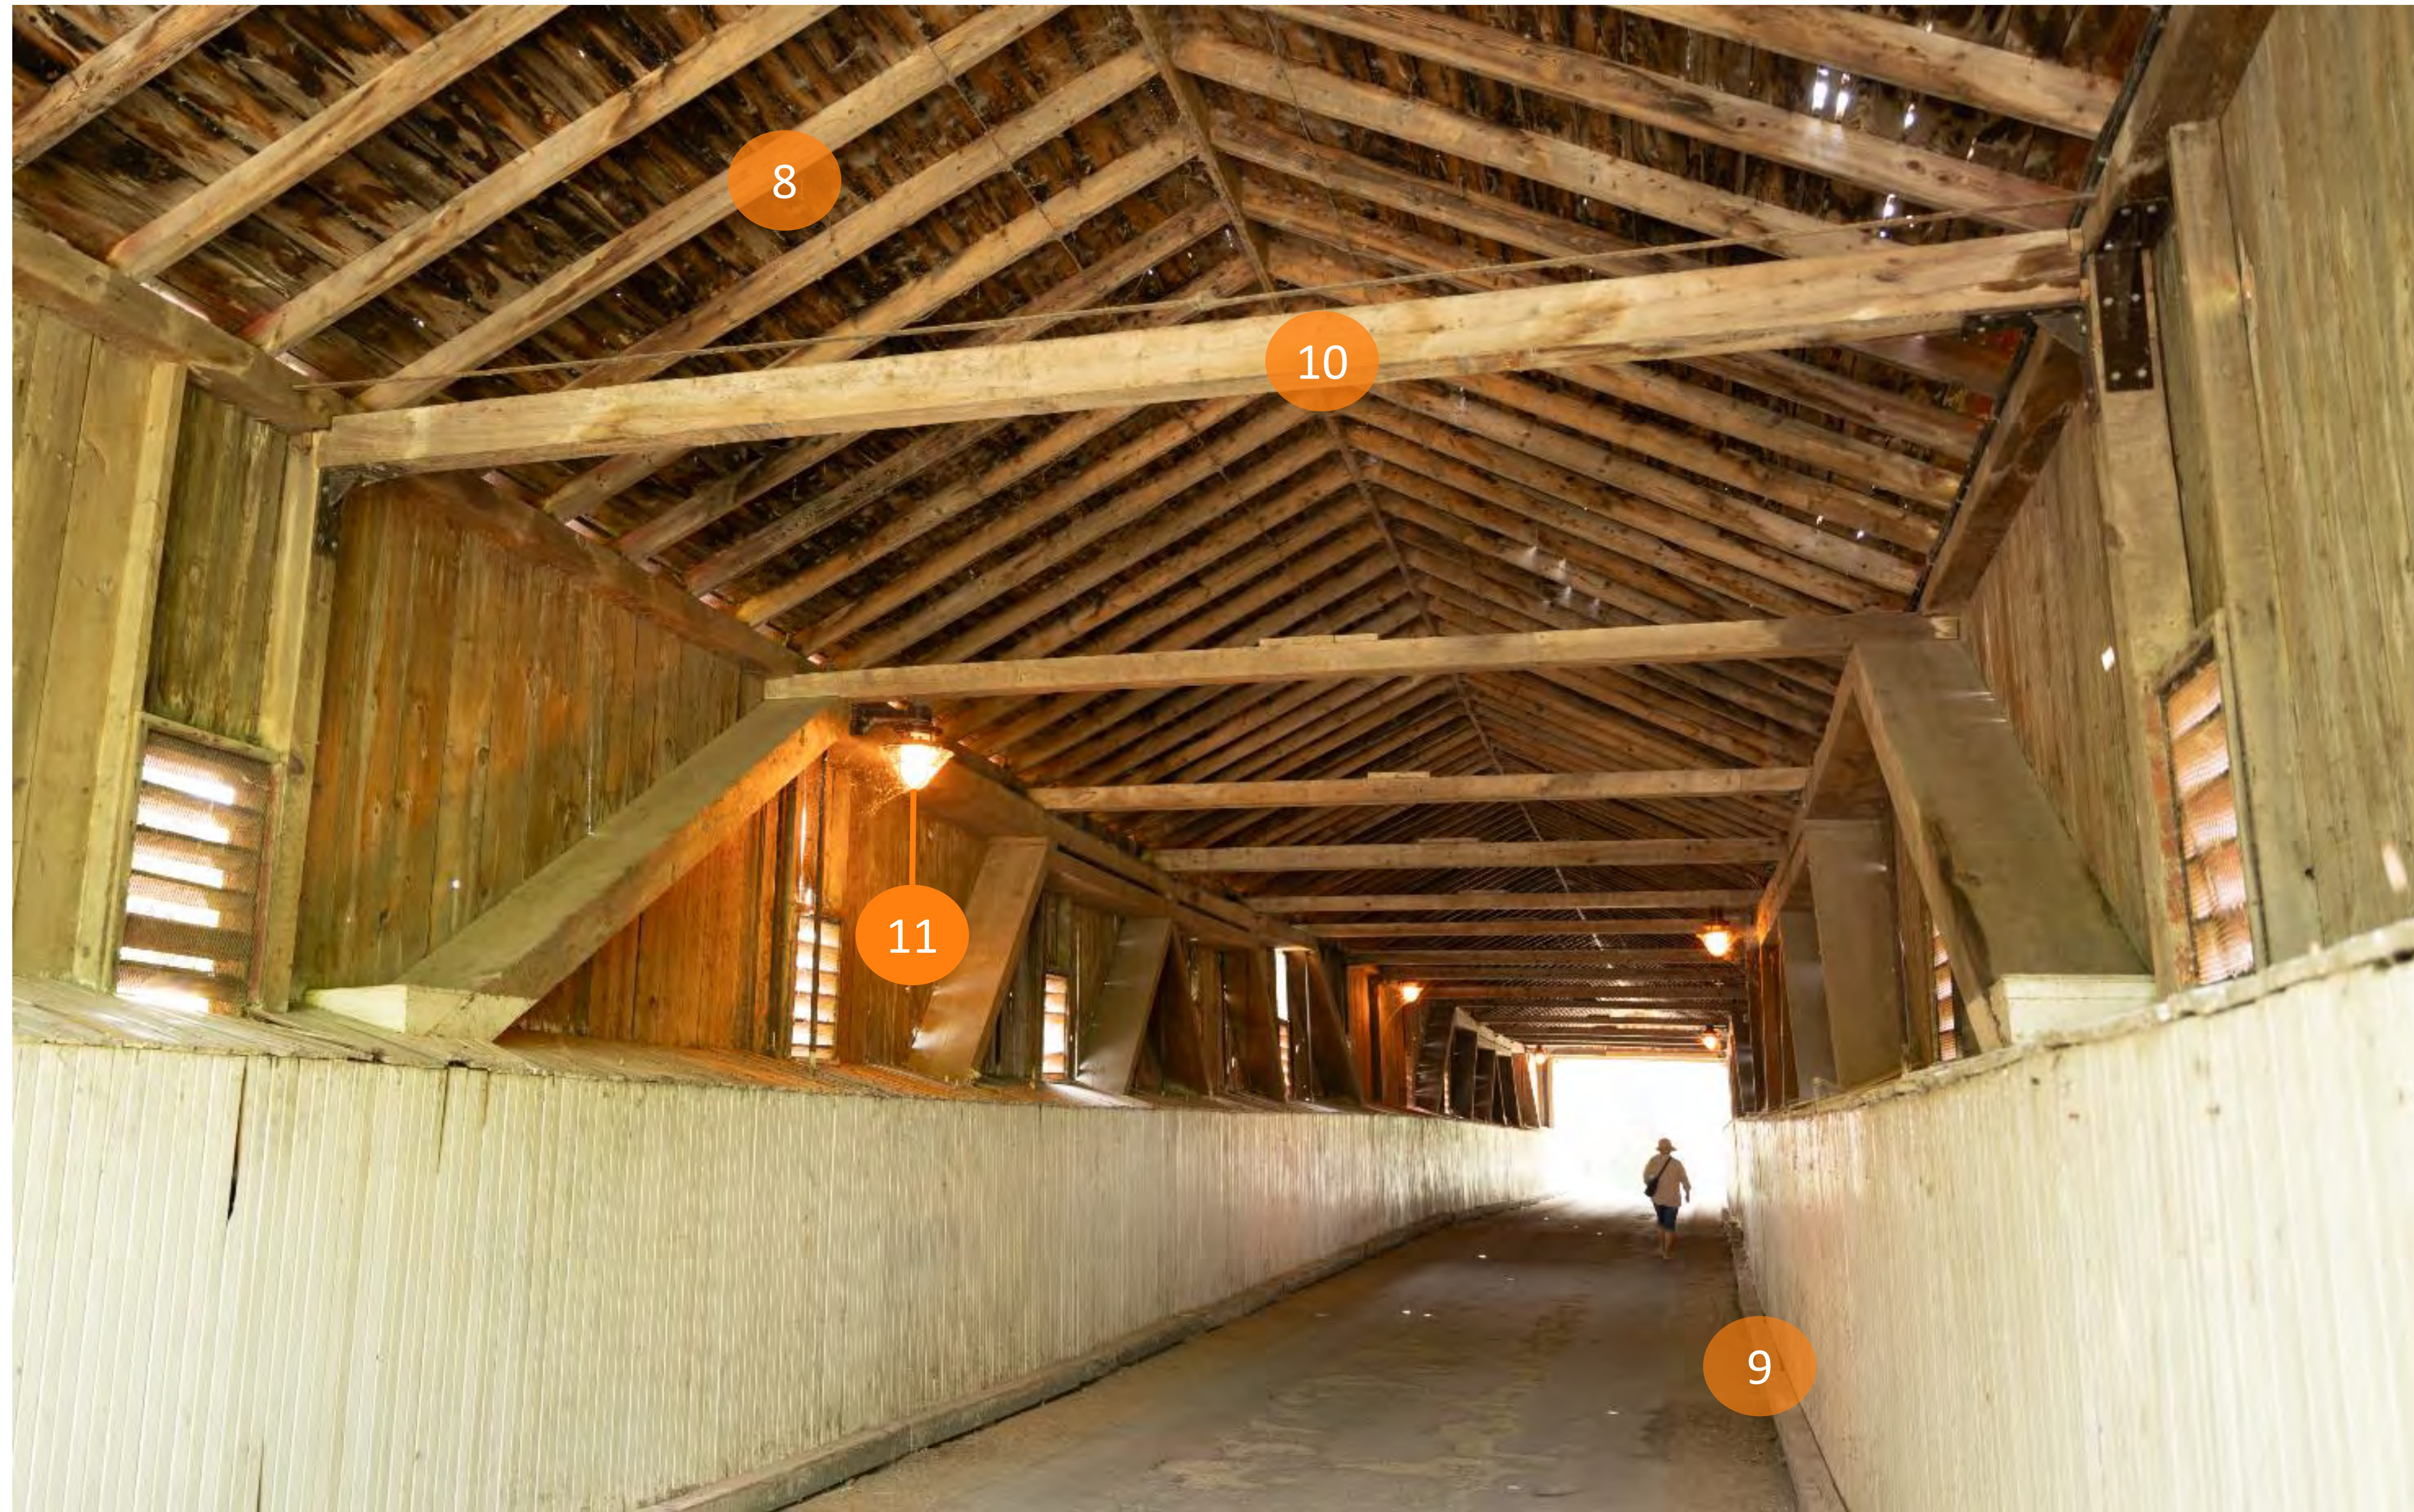
8 Replace rafters as necessary

9 Replace wood curbs

10 Replace tie beams as necessary

11 Replace light bulbs as necessary

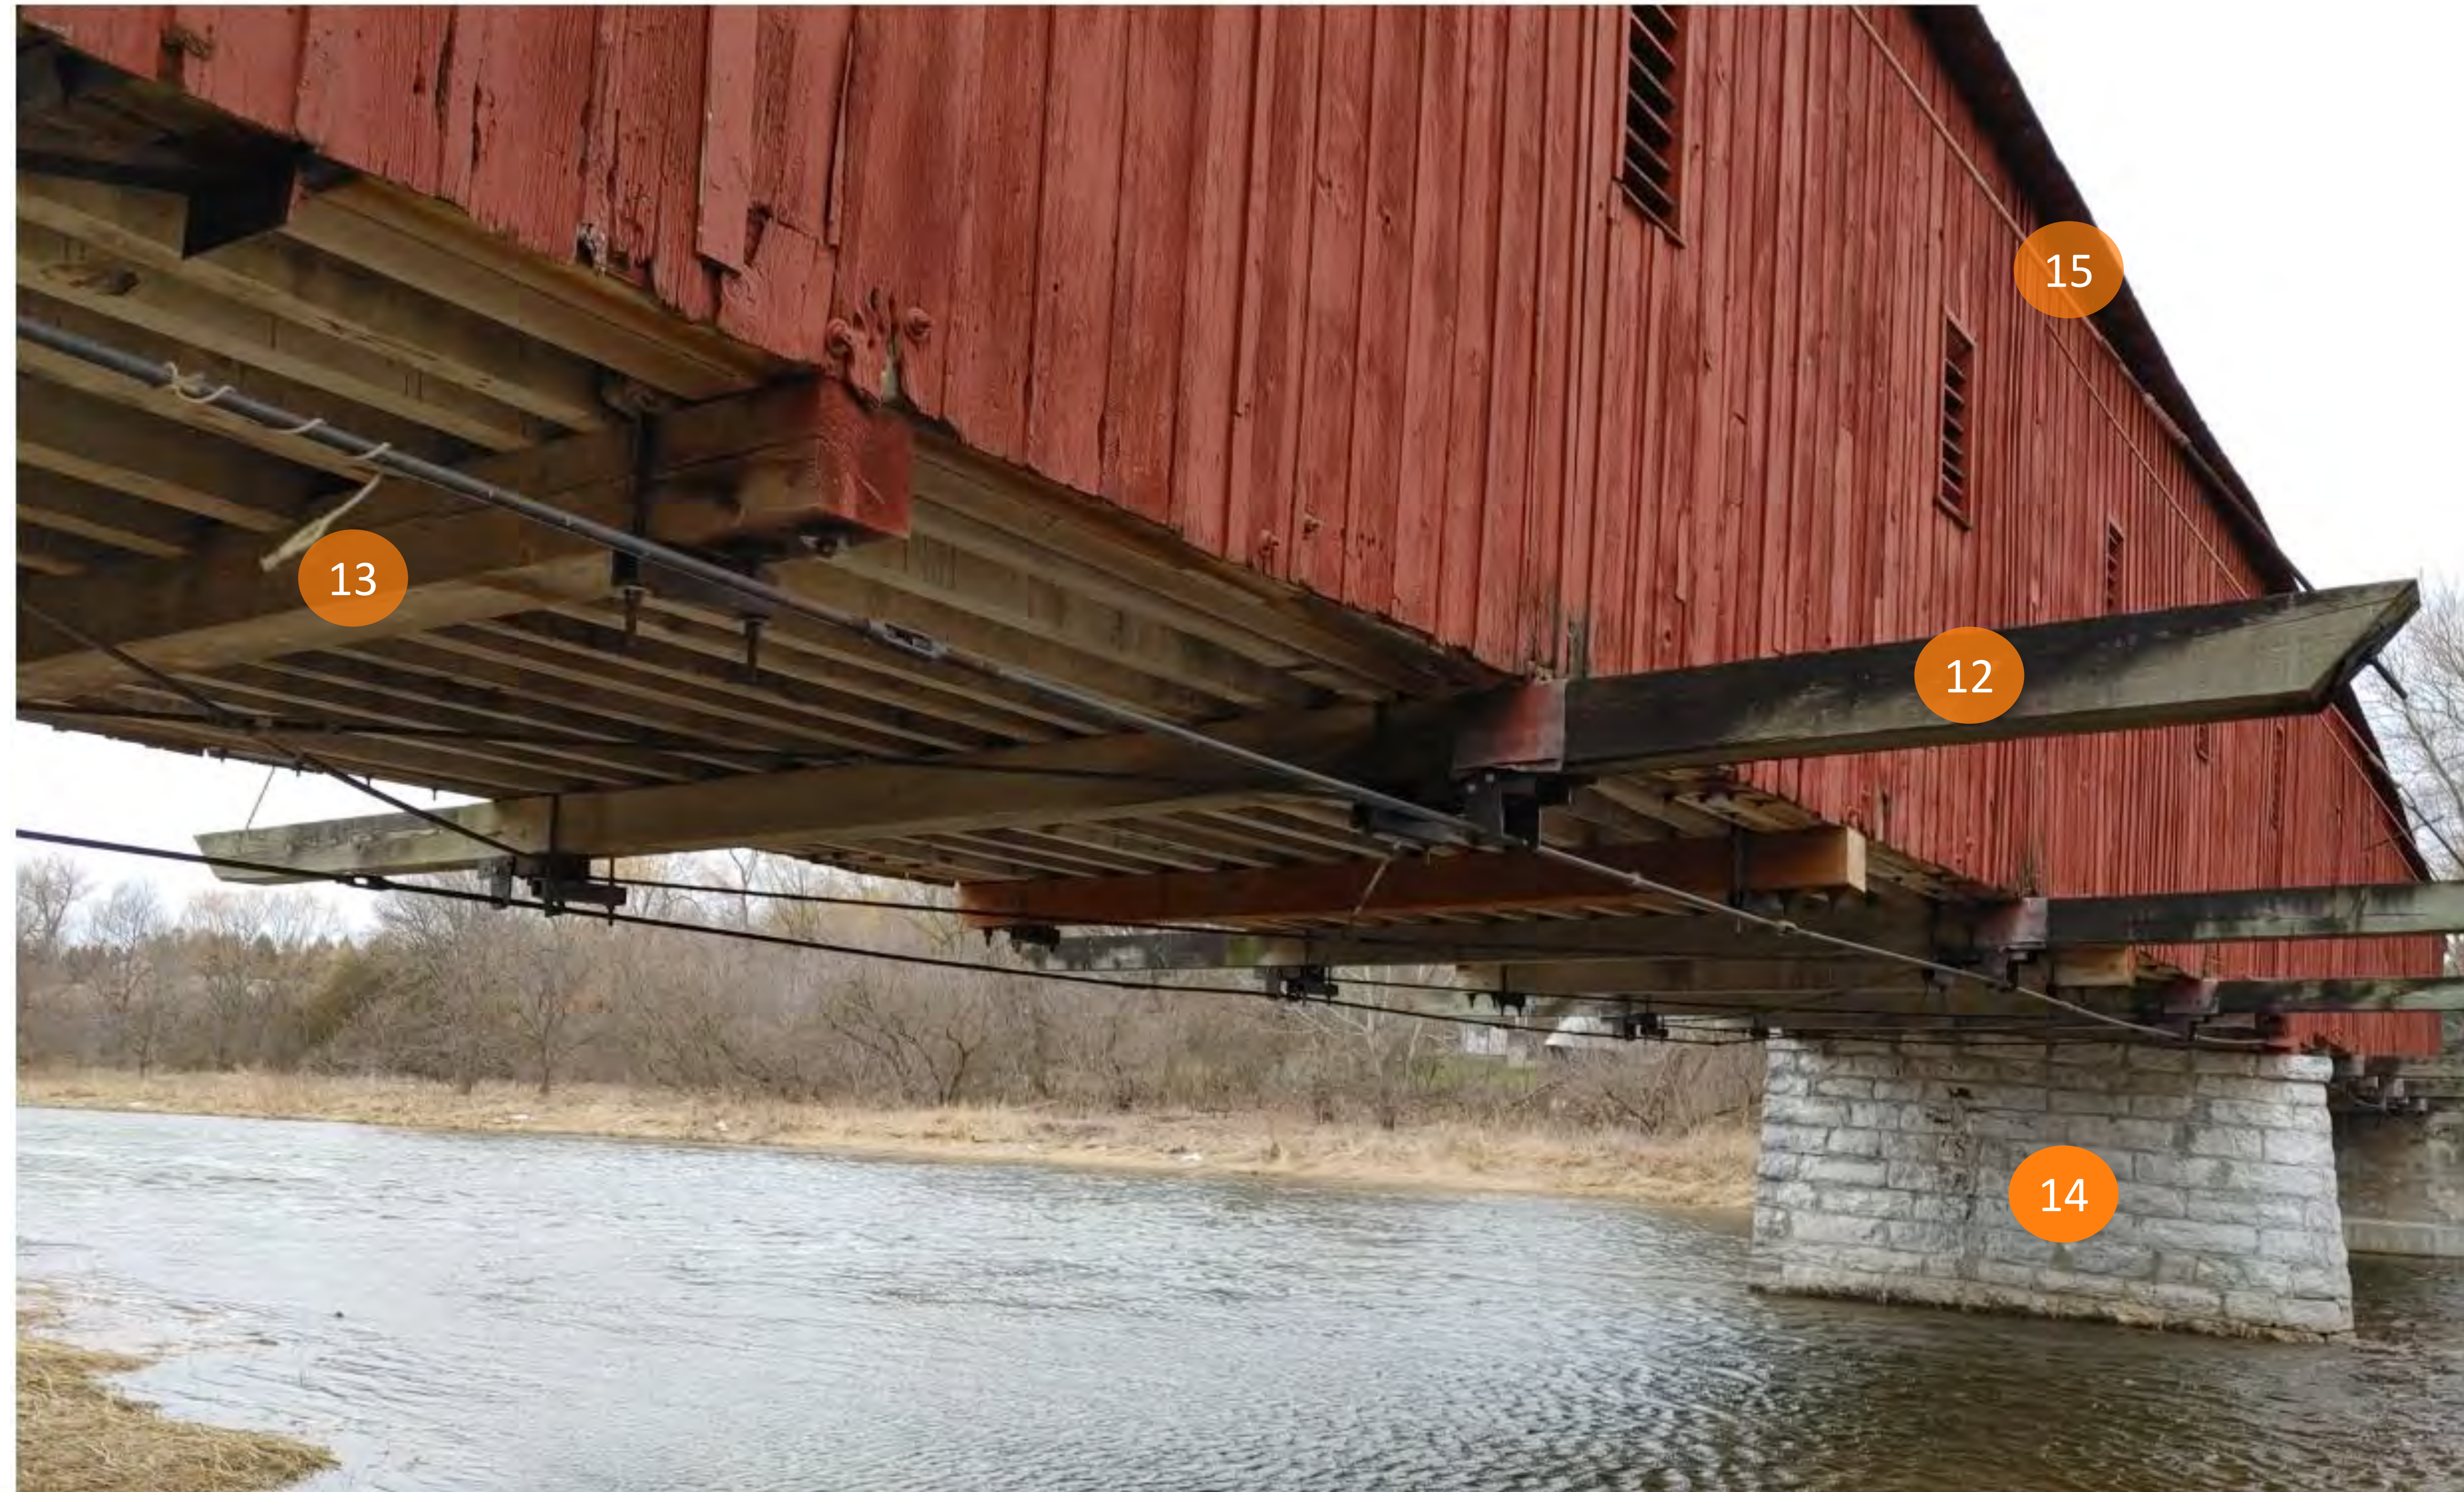
12 Replace needle beams

13 Replace floor beams

14 Repairs to center pier

15 Replace sway bracing

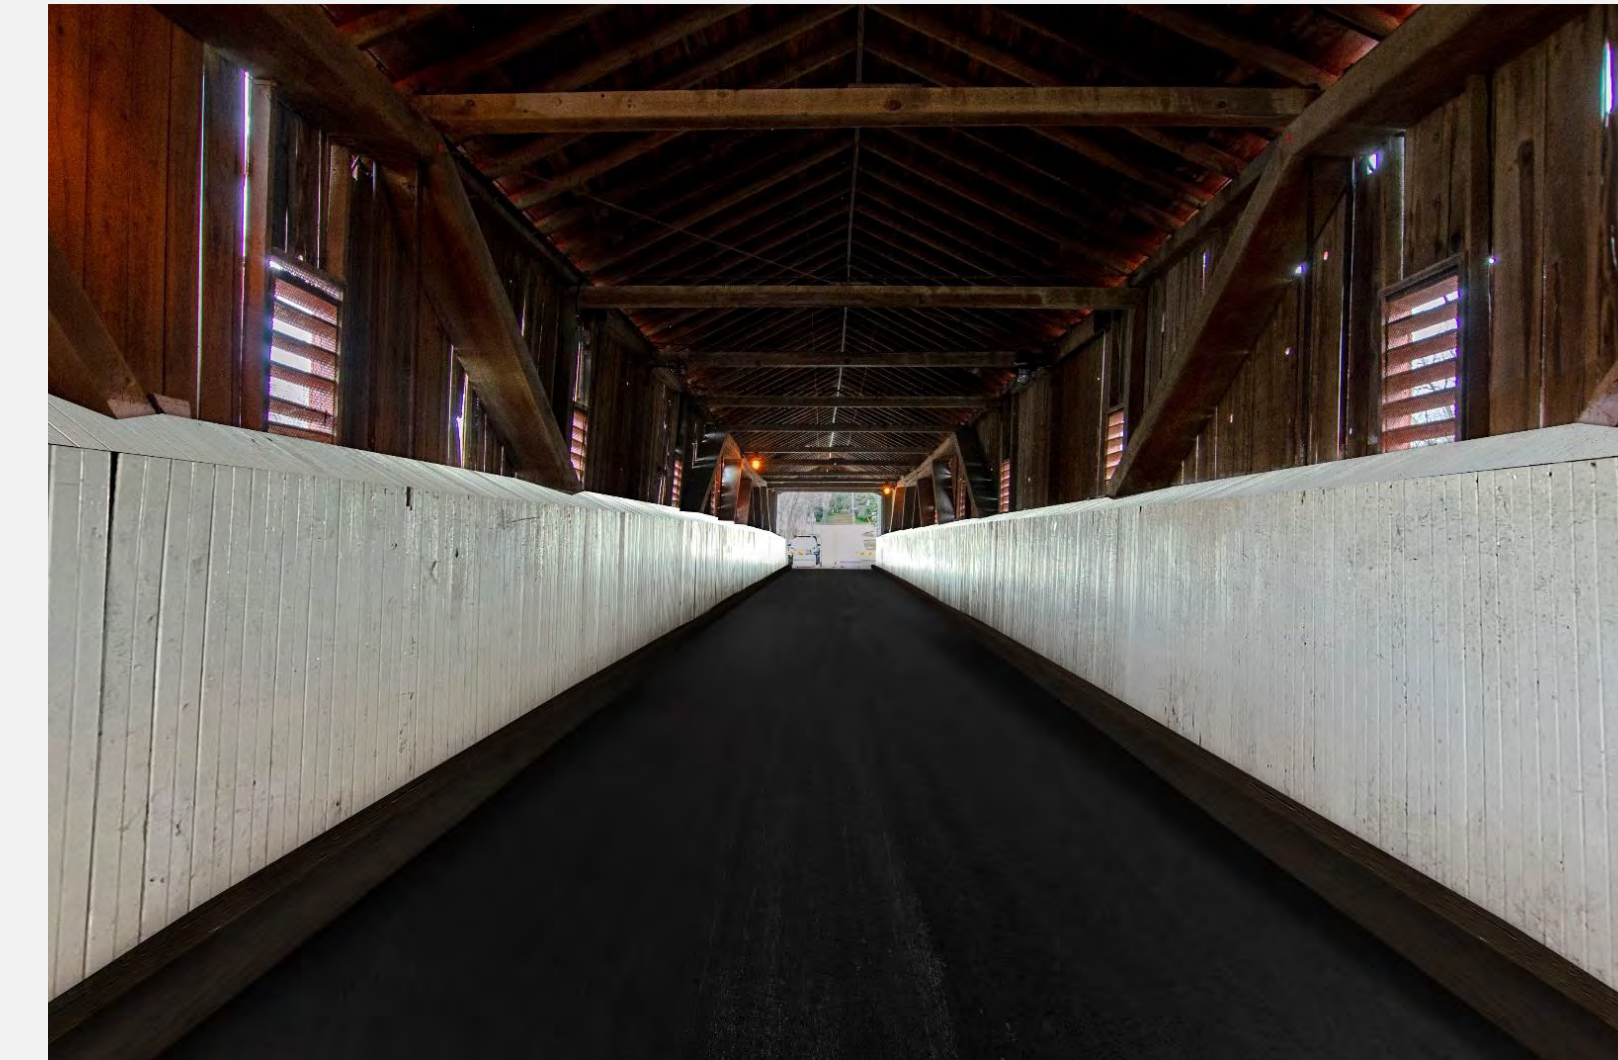
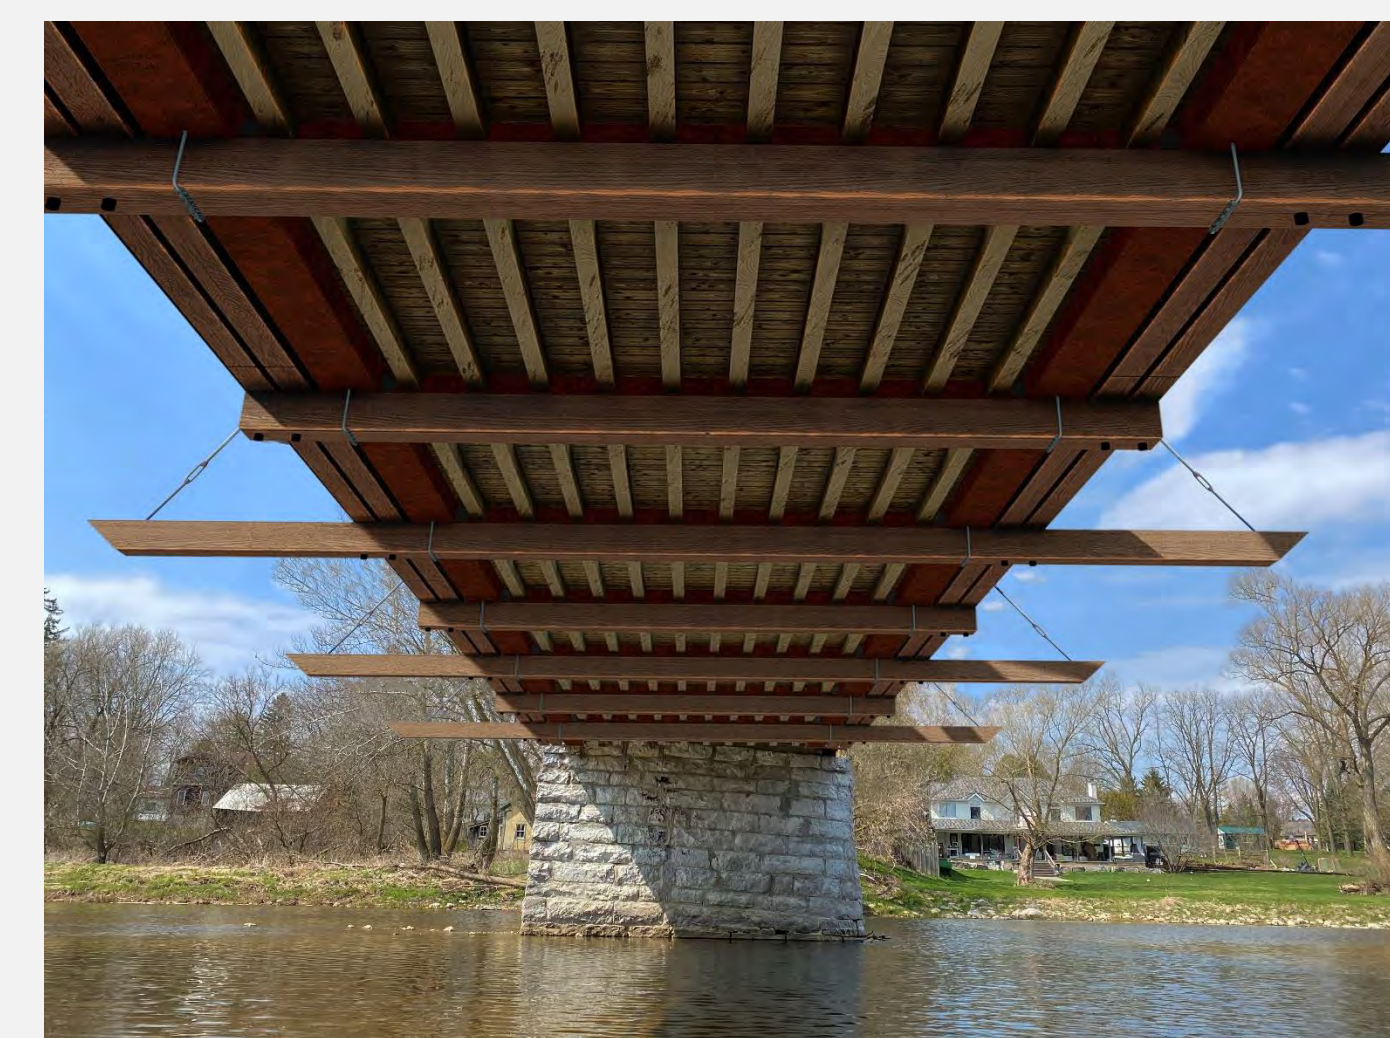
Alternative A – Steel Girder Reinforcement

- Remove Bailey trusses and replace with new steel girders
- New steel girders would be the primary structural system
- Replace interior white cladding
- Bridge interior would look similar to the way it looks today
- Width of driving lane would become slightly more narrow
- Includes new steel floor beams
- Can accommodate a design live load of approximately 15 tonnes

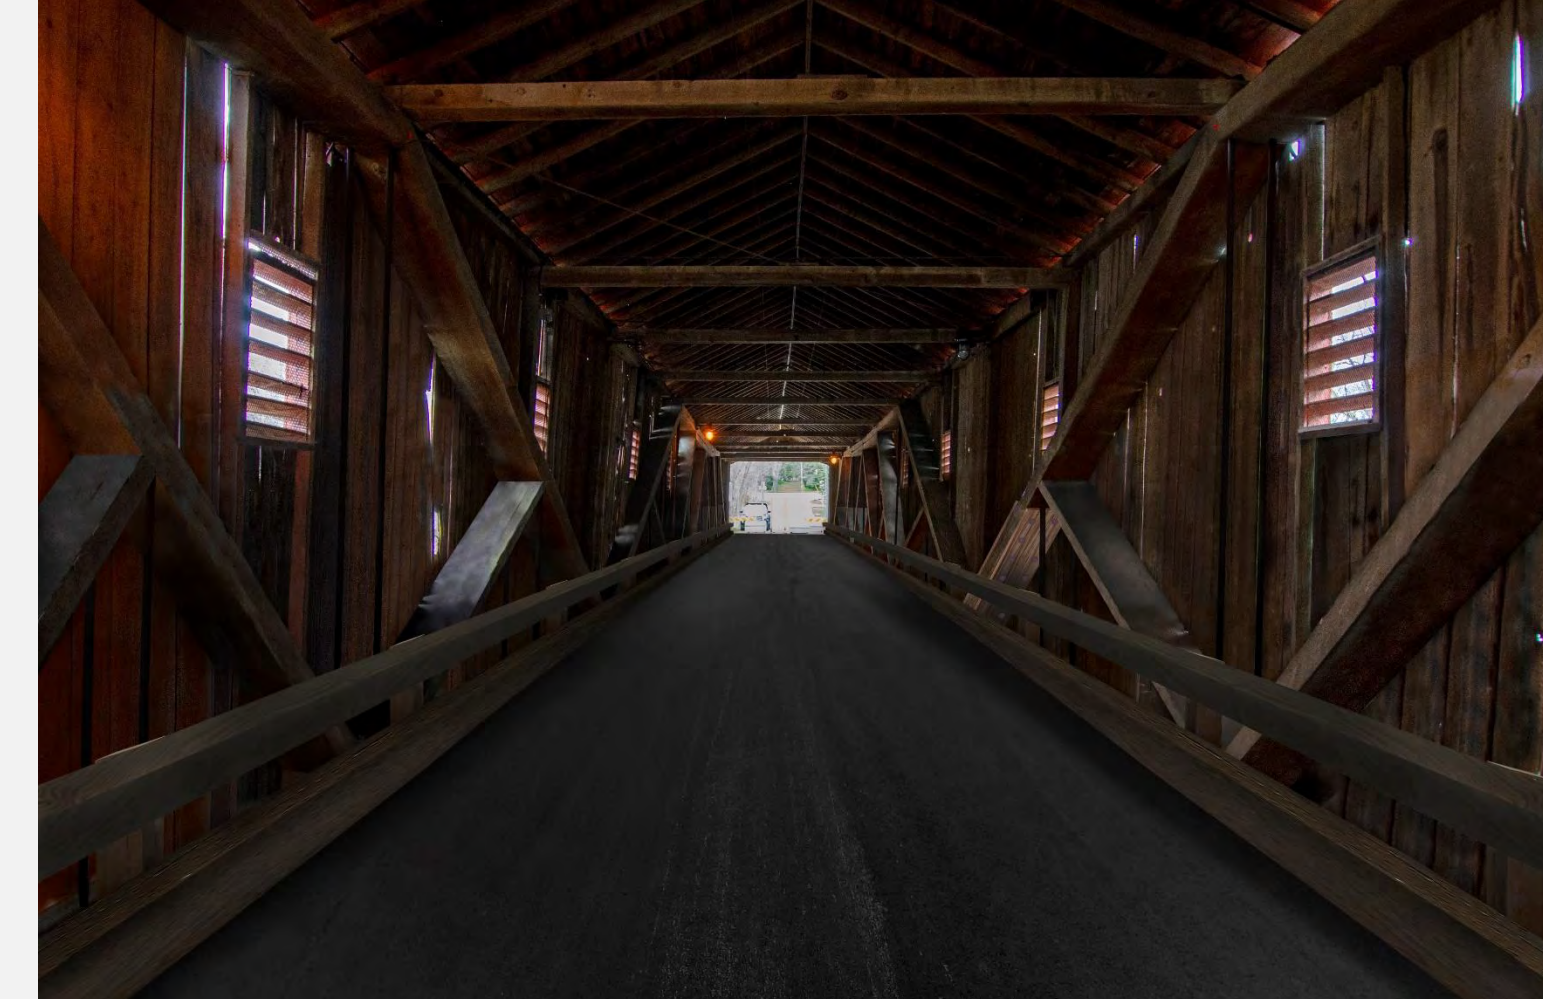
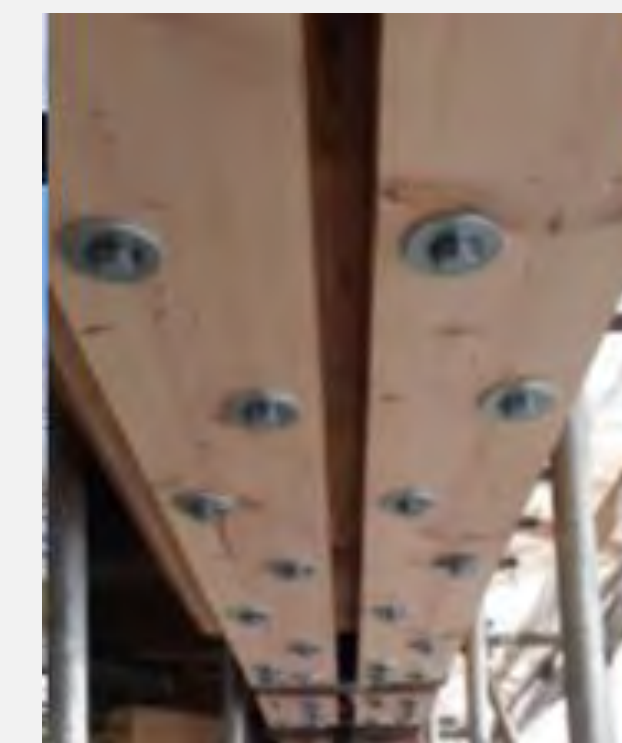
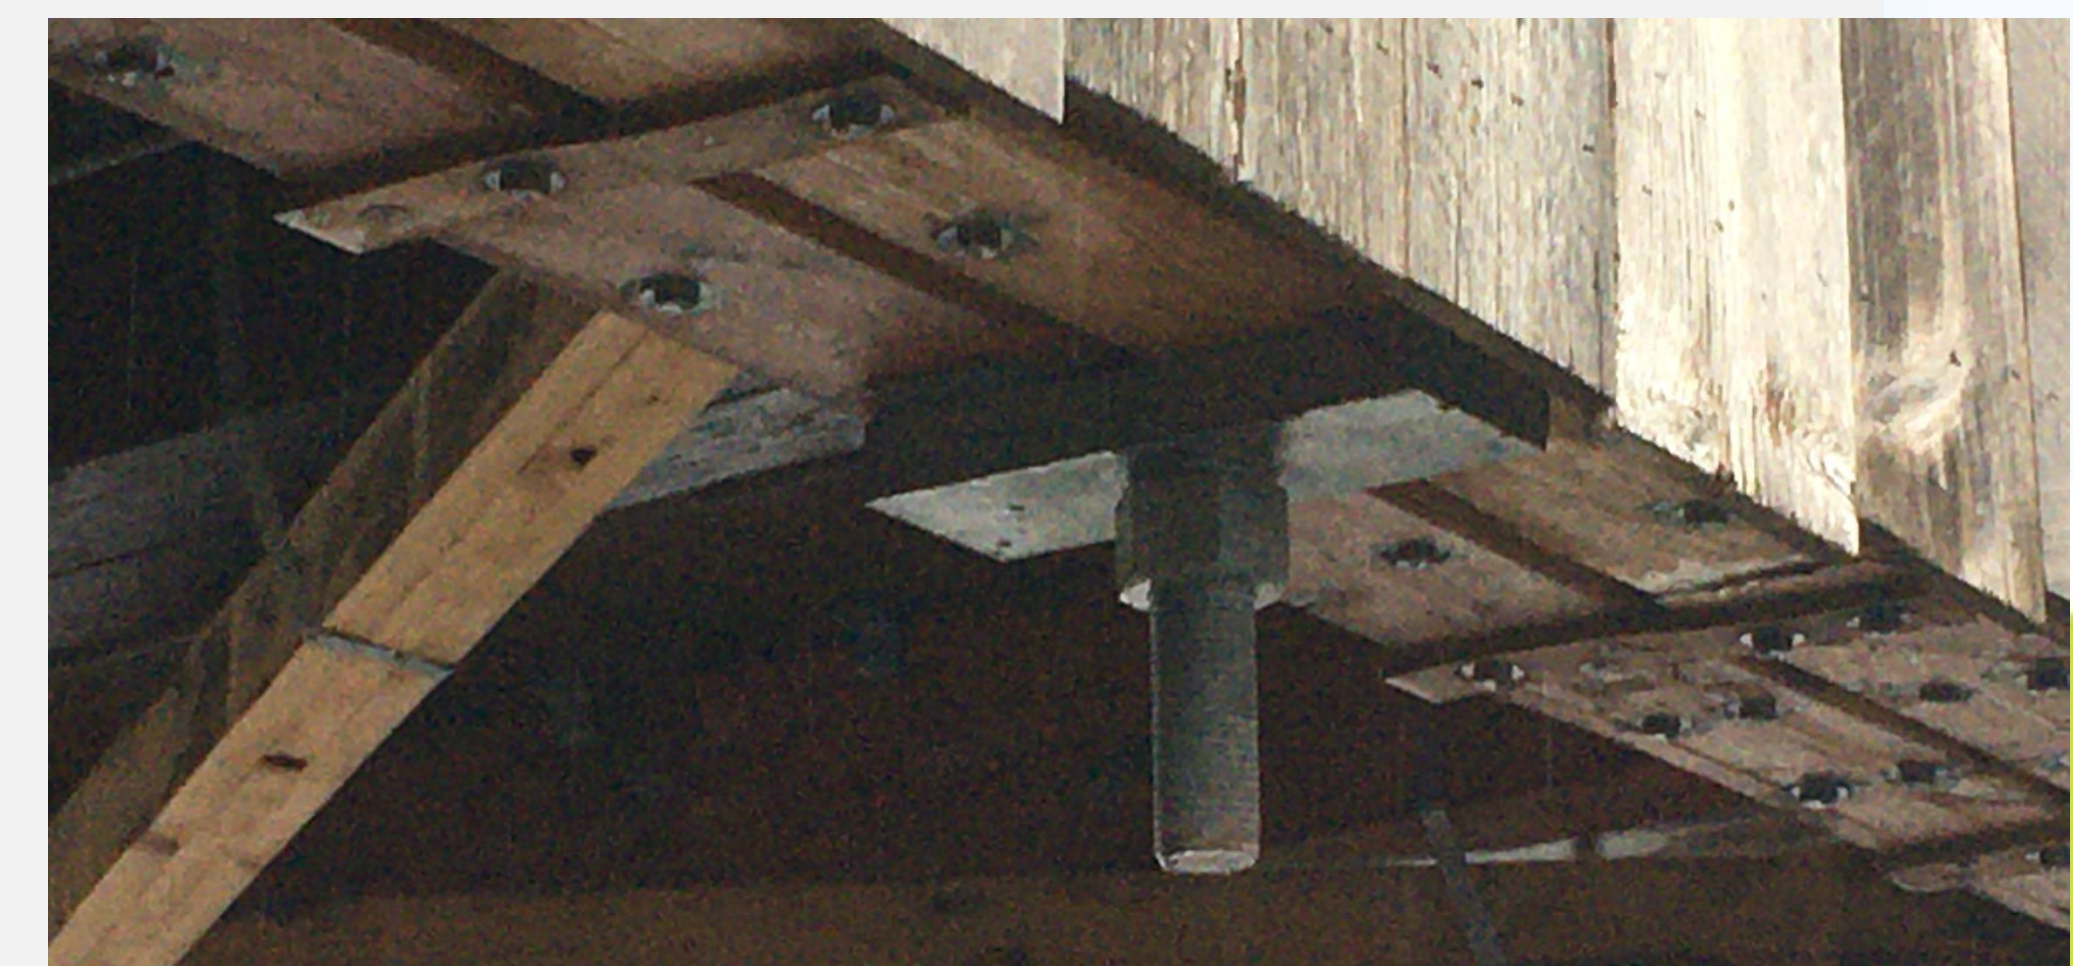
Alternative B – Timber Truss Reinforcement with Fibre-reinforced Polymer (FRP)

- Remove Bailey truss and strengthen the existing wooden truss with high-strength fibre reinforcement attached to the bottom chord
- Reinforce deteriorated truss members
- Remove interior white cladding
- Install timber guardrail to protect wooden truss
- FRP bonding to the bottom chord of the truss was determined to be **unsuitable** due to the deteriorated condition of the bottom chord discovered during the timber inspection. The bottom chord is recommended for replacement.

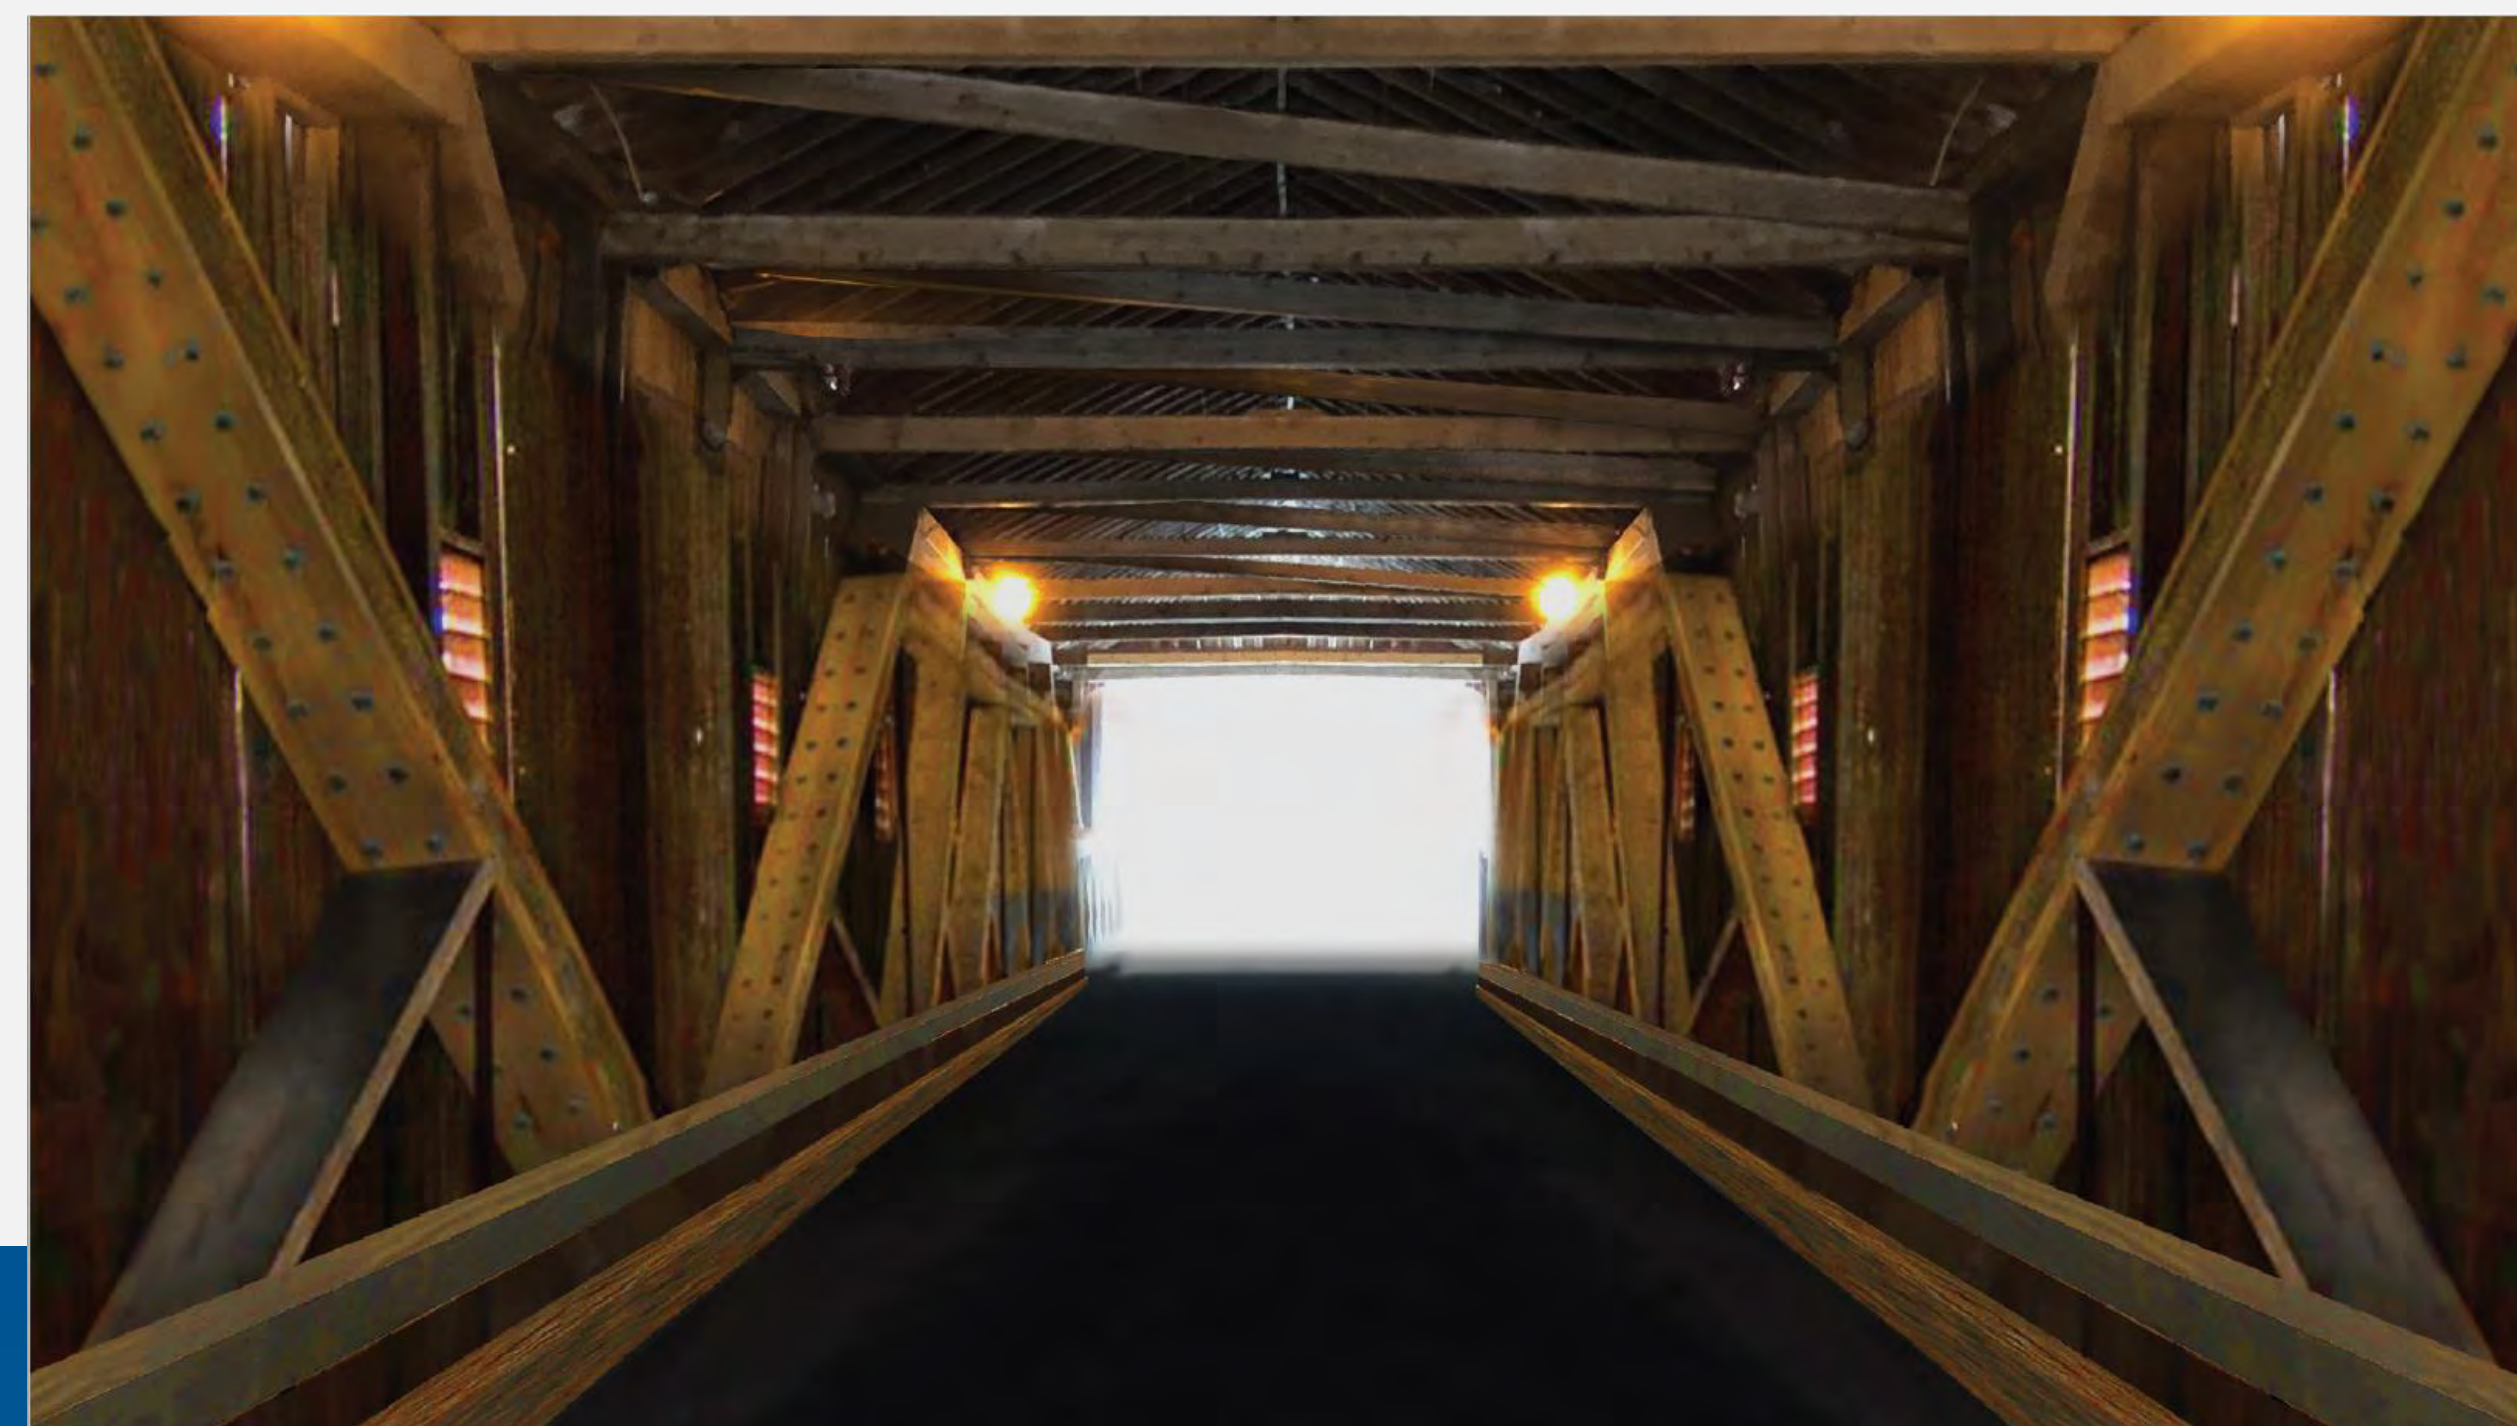
Removal of the existing Bailey truss and strengthening of the existing wooden truss to a **10 tonne design live load**, by replacing and/or strengthening specific wooden truss members, including:

- Replace floor beams and needle beams with new 16"x16" Douglas fir beams
- Replace bottom chord with new Douglas Fir members
- Make lower top chord composite with top chord by adding wood plate between top chord and lower top chord and fastening together
- Strengthen end diagonals by fastening on new 4" (89mm) thick wood planks
- Remove interior cladding and reinstate in short sections in each corner
