West Montrose Covered Bridge Rehabilitation

Township of Woolwich Heritage Committee Meeting

November 8, 2023

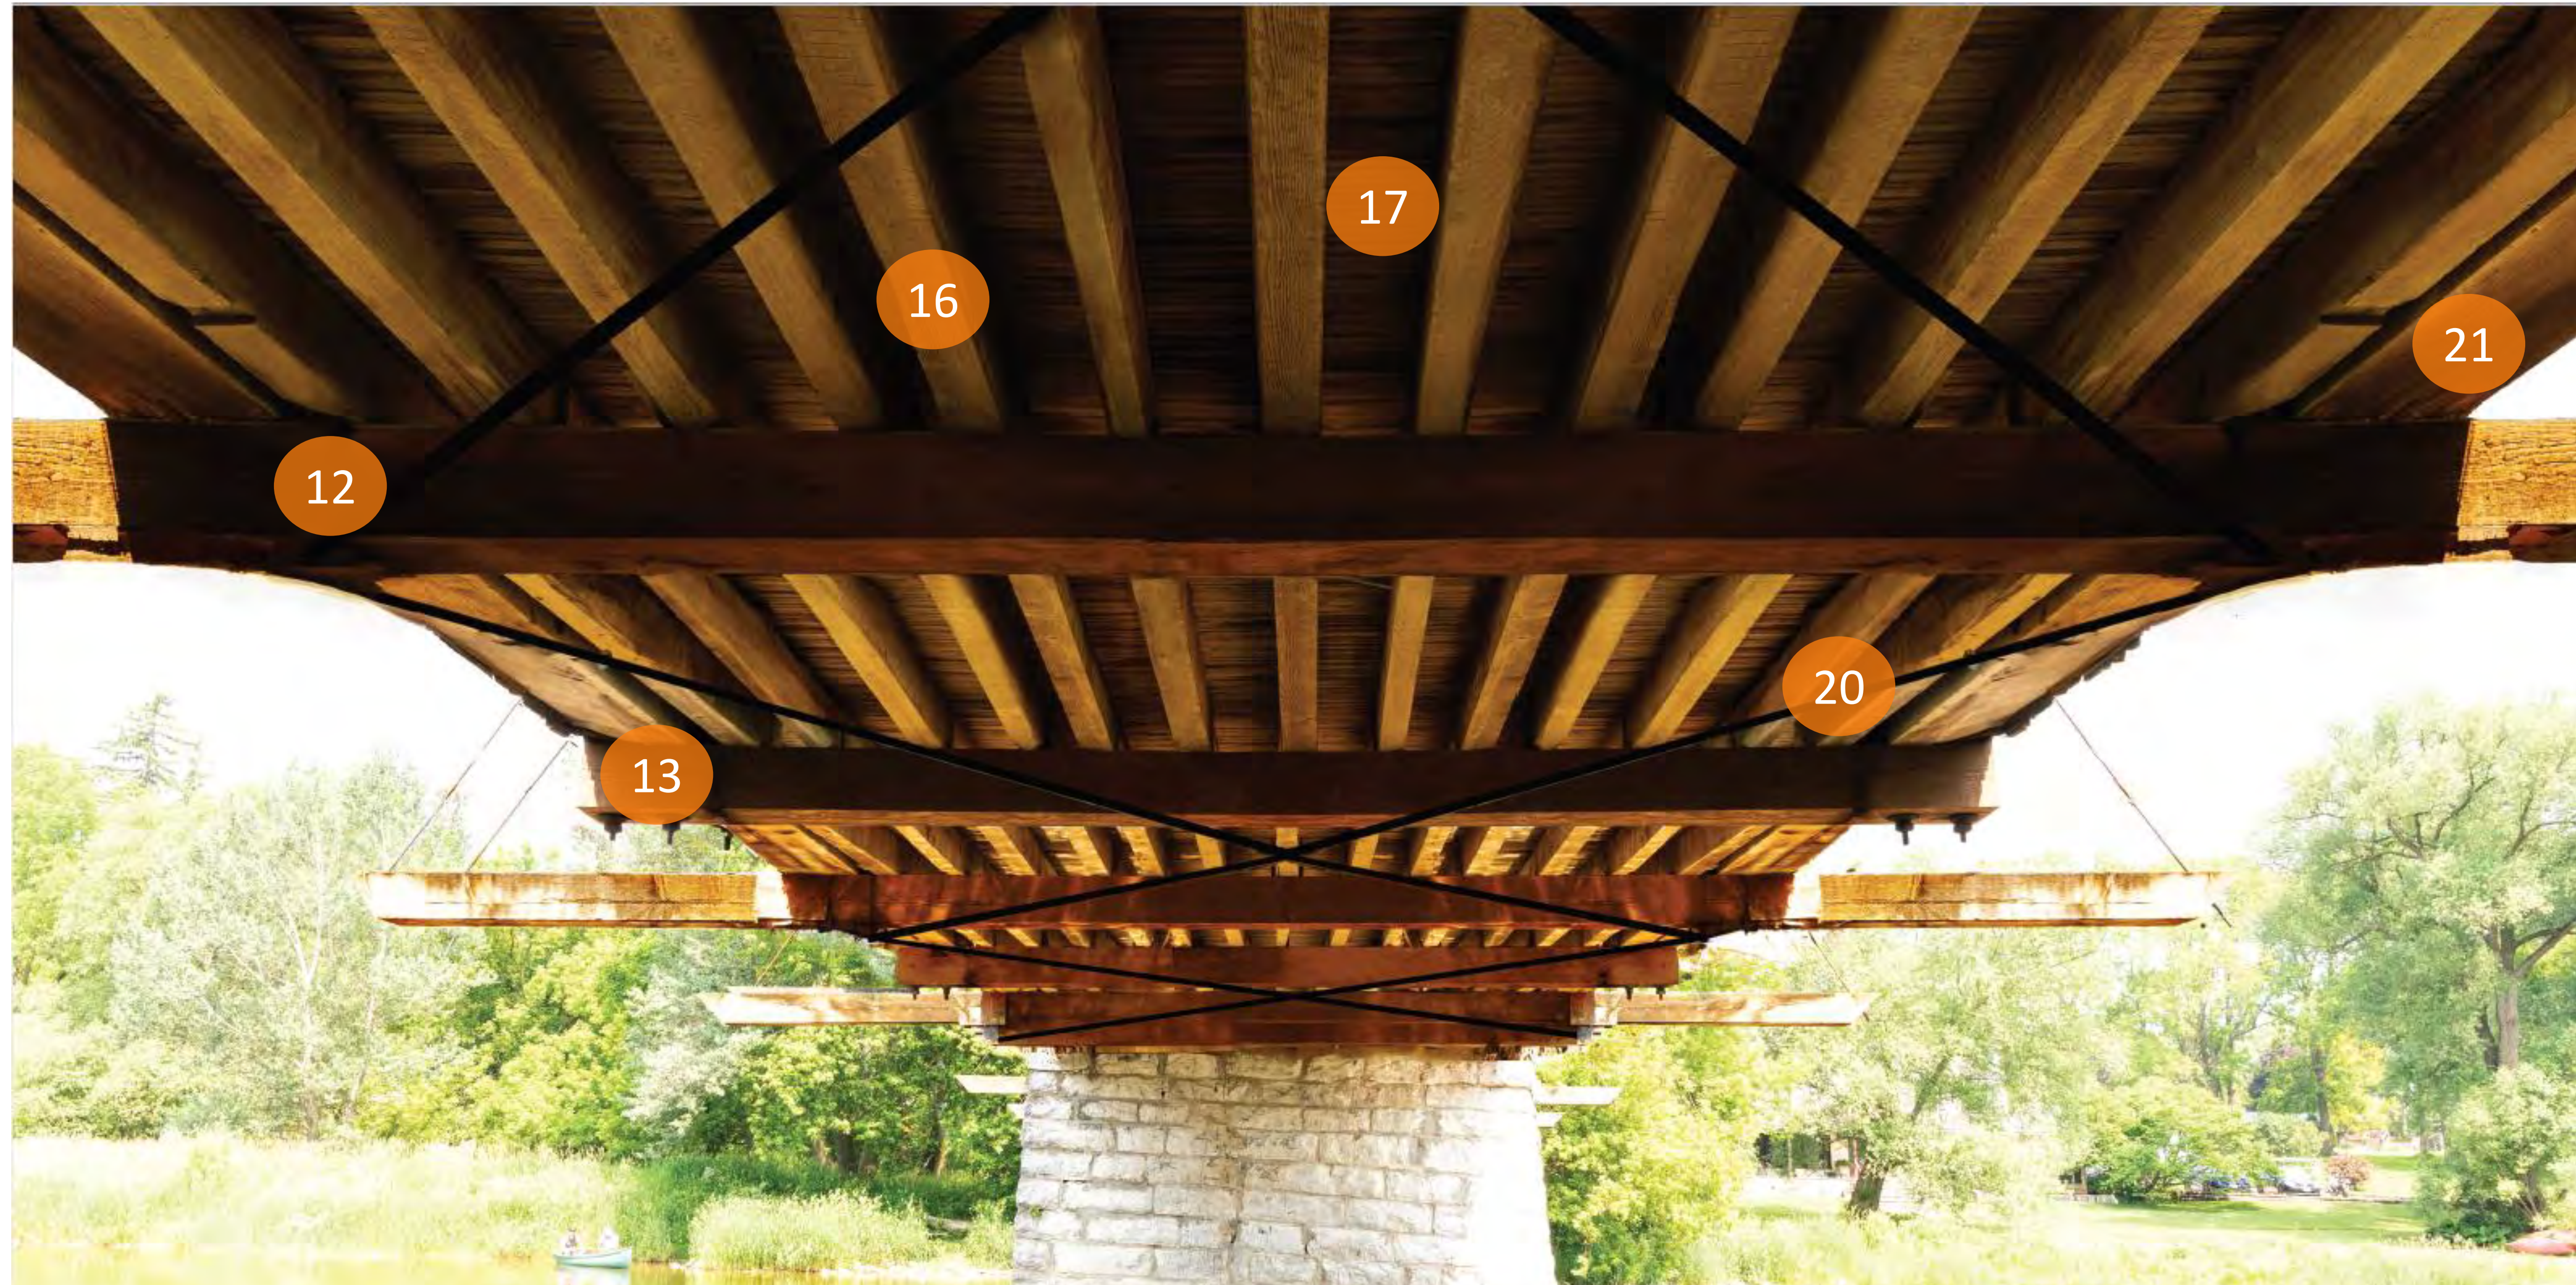
- 12 New Douglas Fir 16"x16" needle beams
- 13 New Douglas Fir 16"x16" floor beams
- 16 New sawn wood stringers
- 17 New nail-laminated wood deck
- 20 New steel rod cross-bracing
- 21 New Douglas Fir bottom chord member

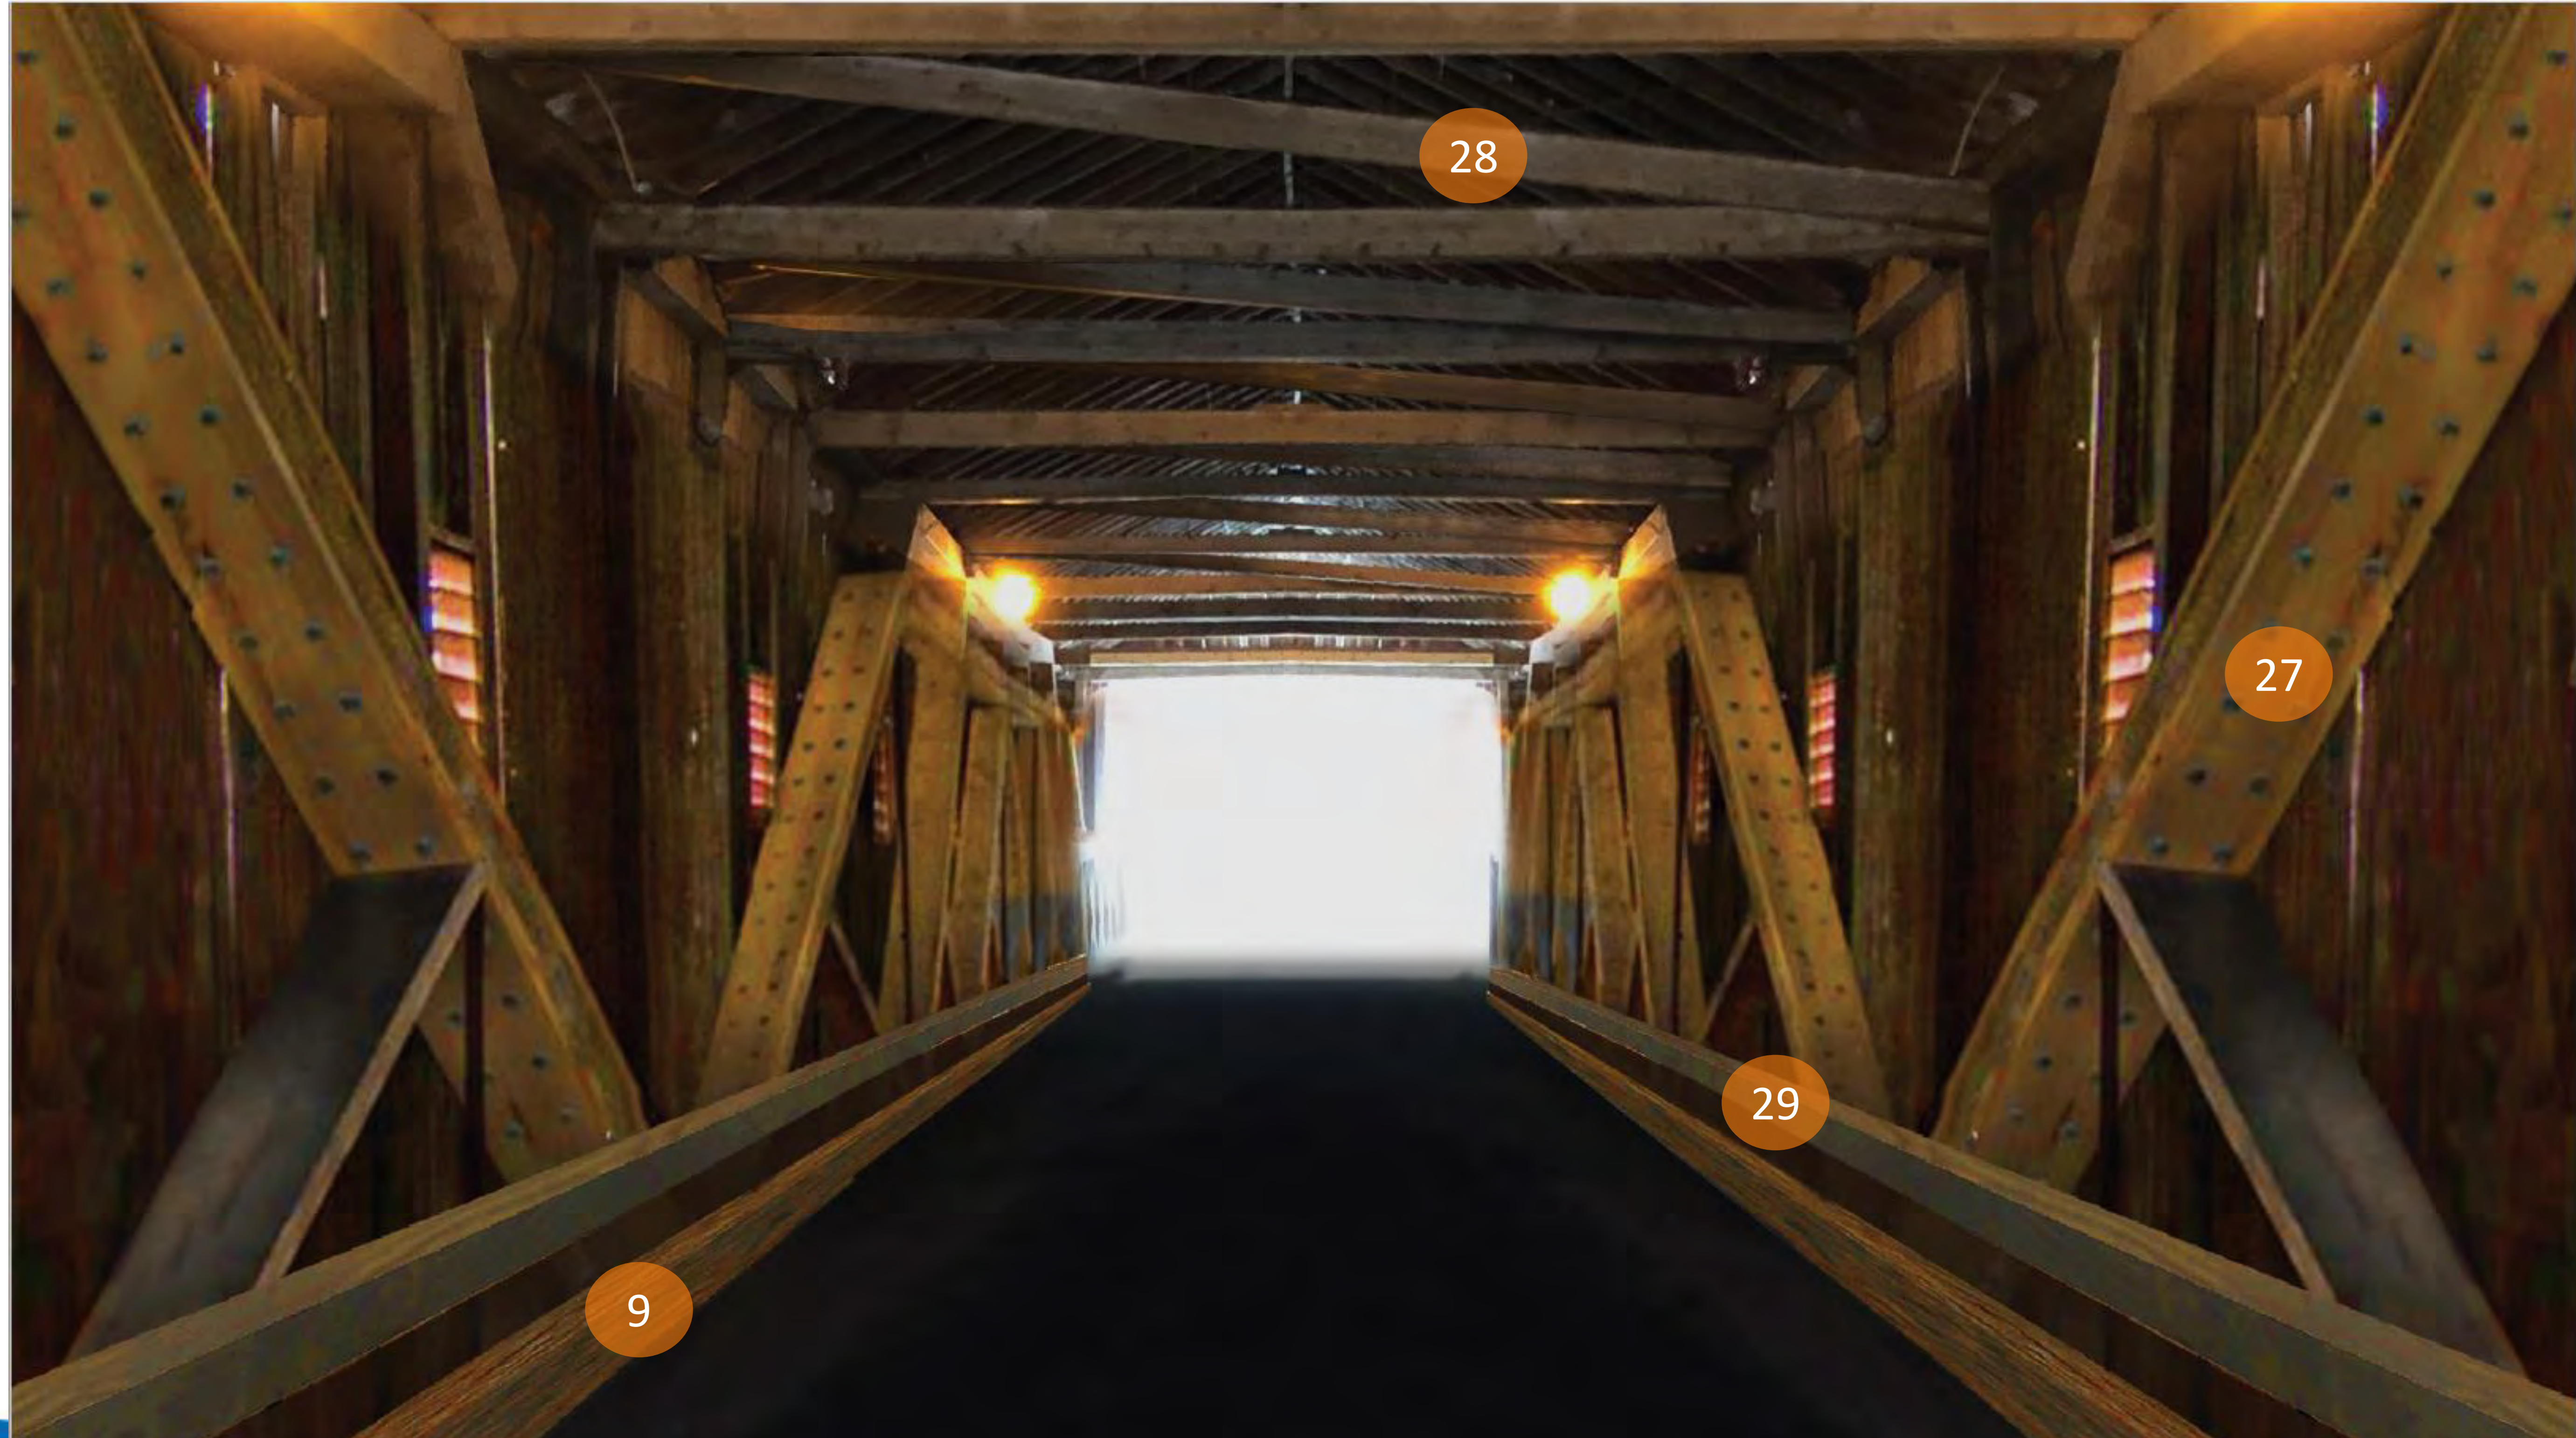
9 New wood curbs

27 Strengthen end diagonals

28 New overhead wood lateral bracing

29 New timber guiderail

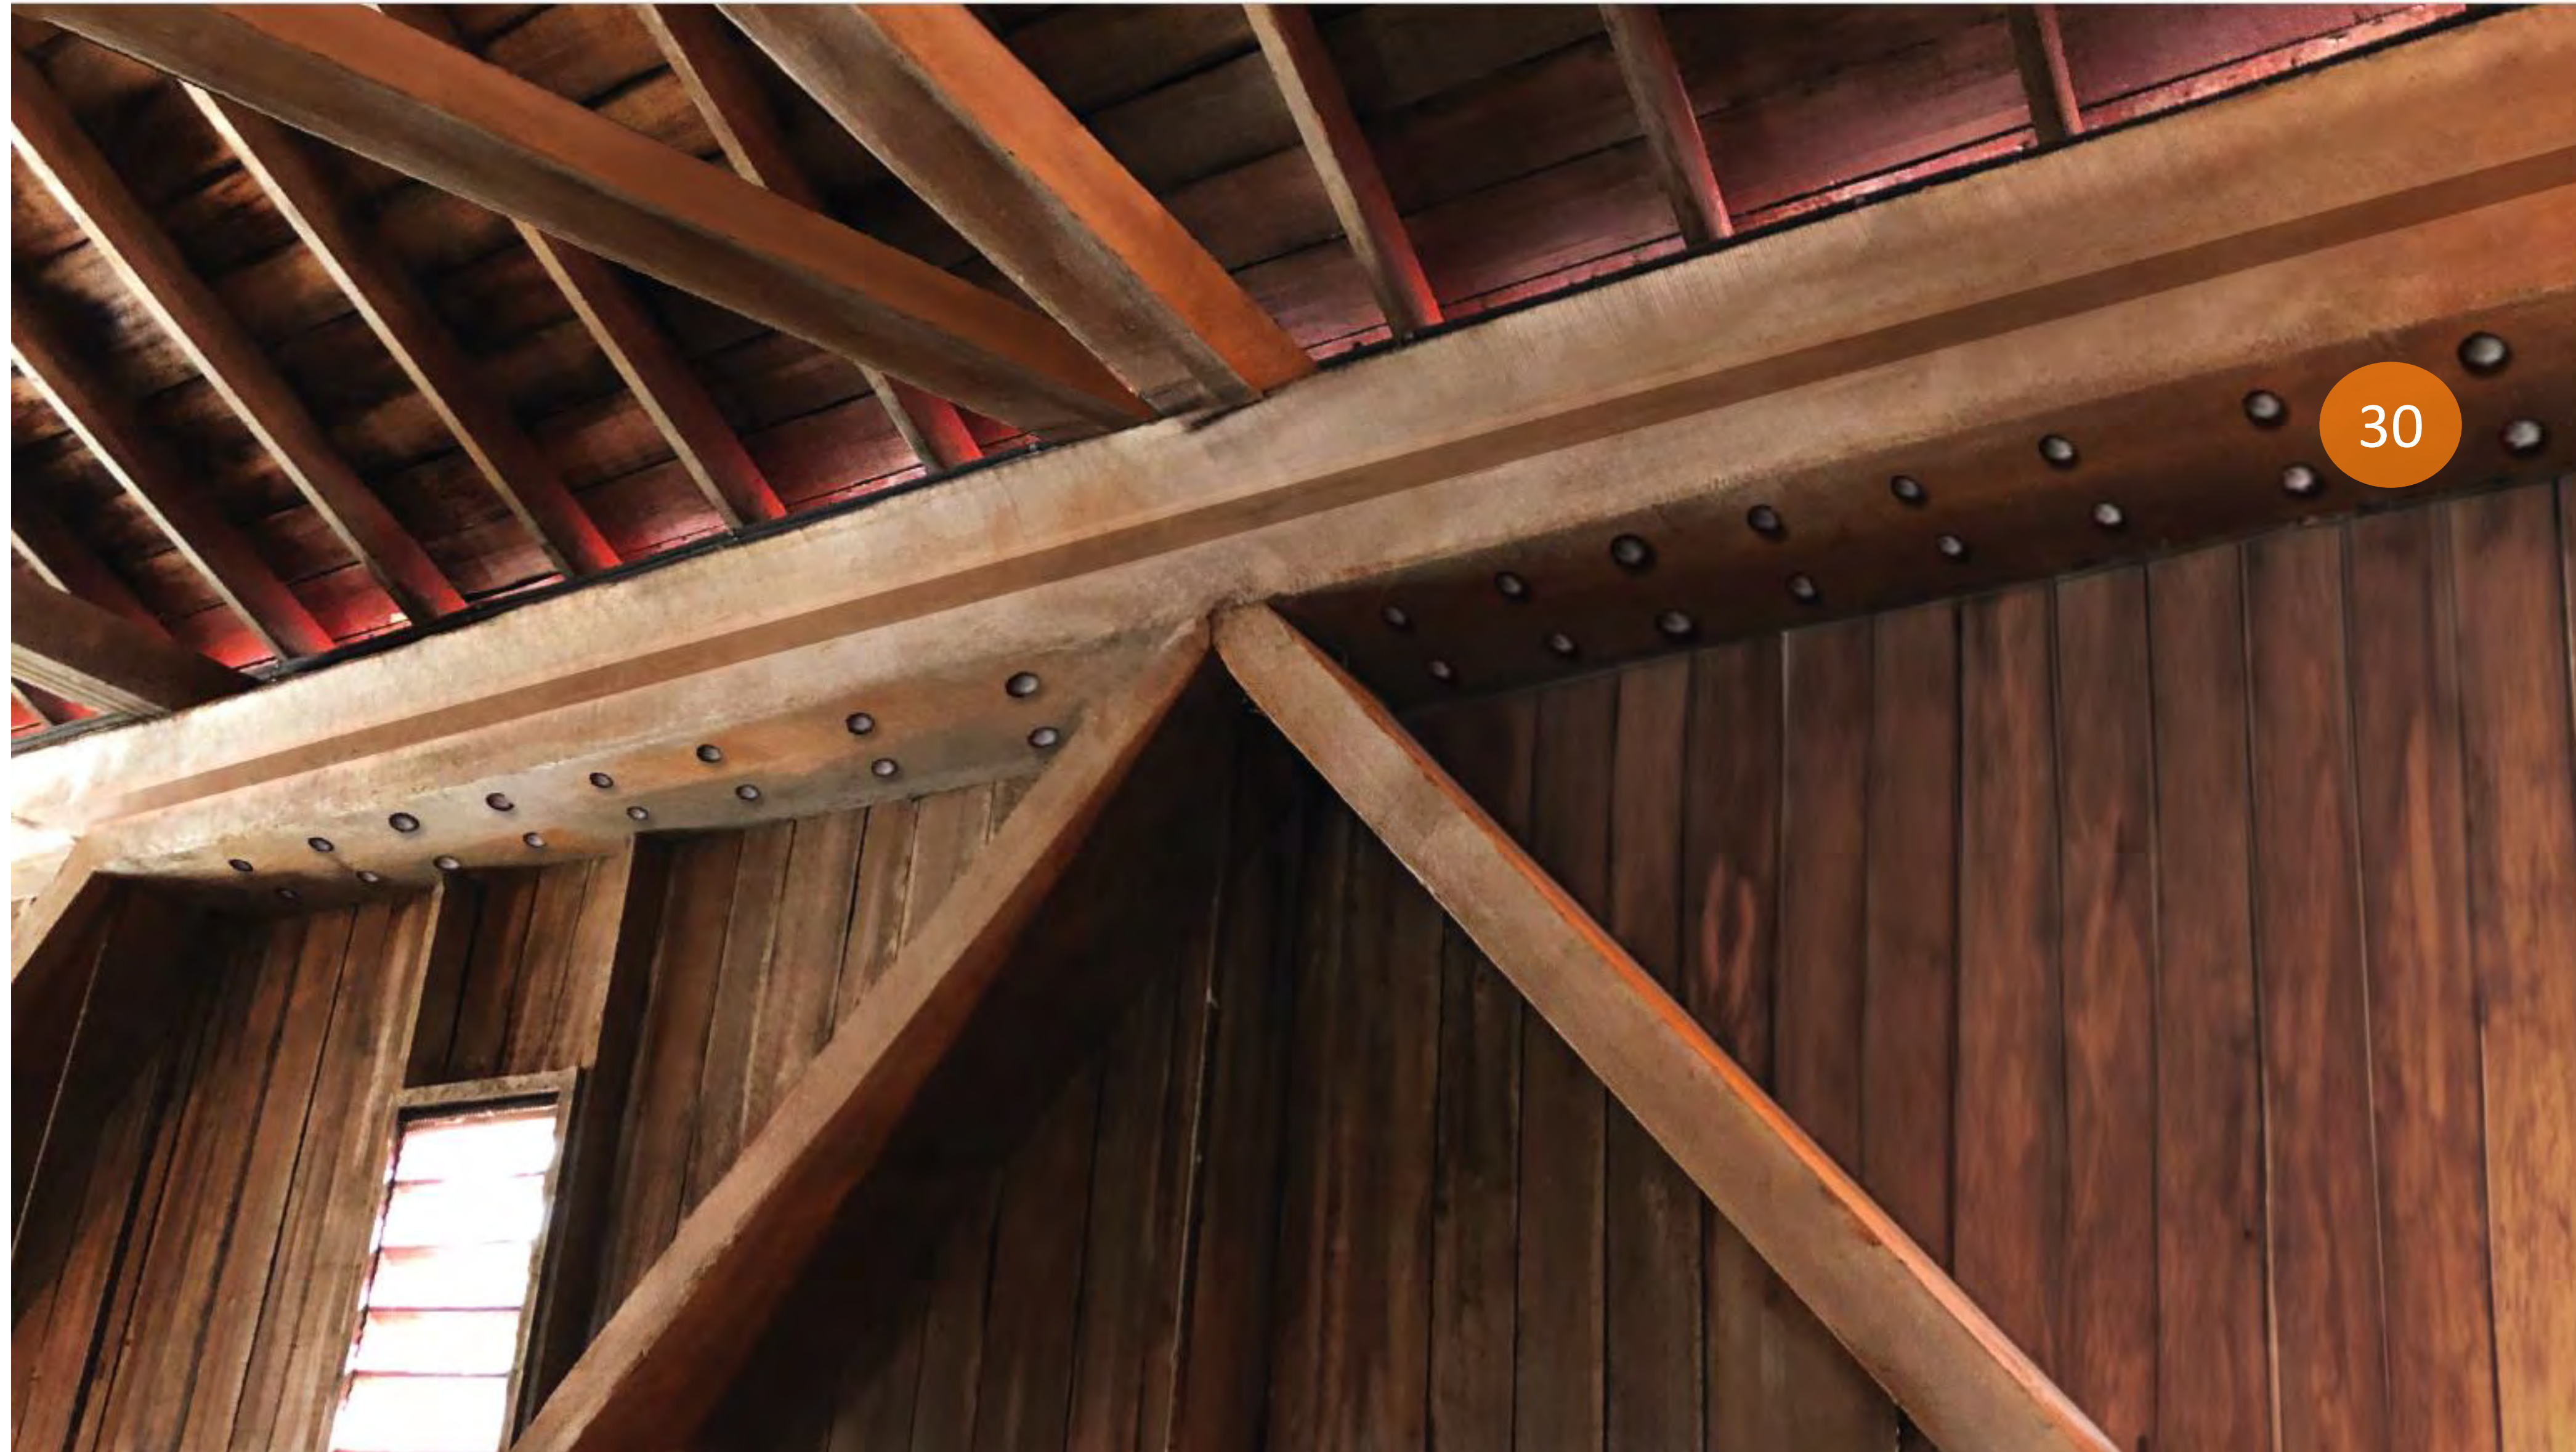
30 Reinforce top chord with lower top chord

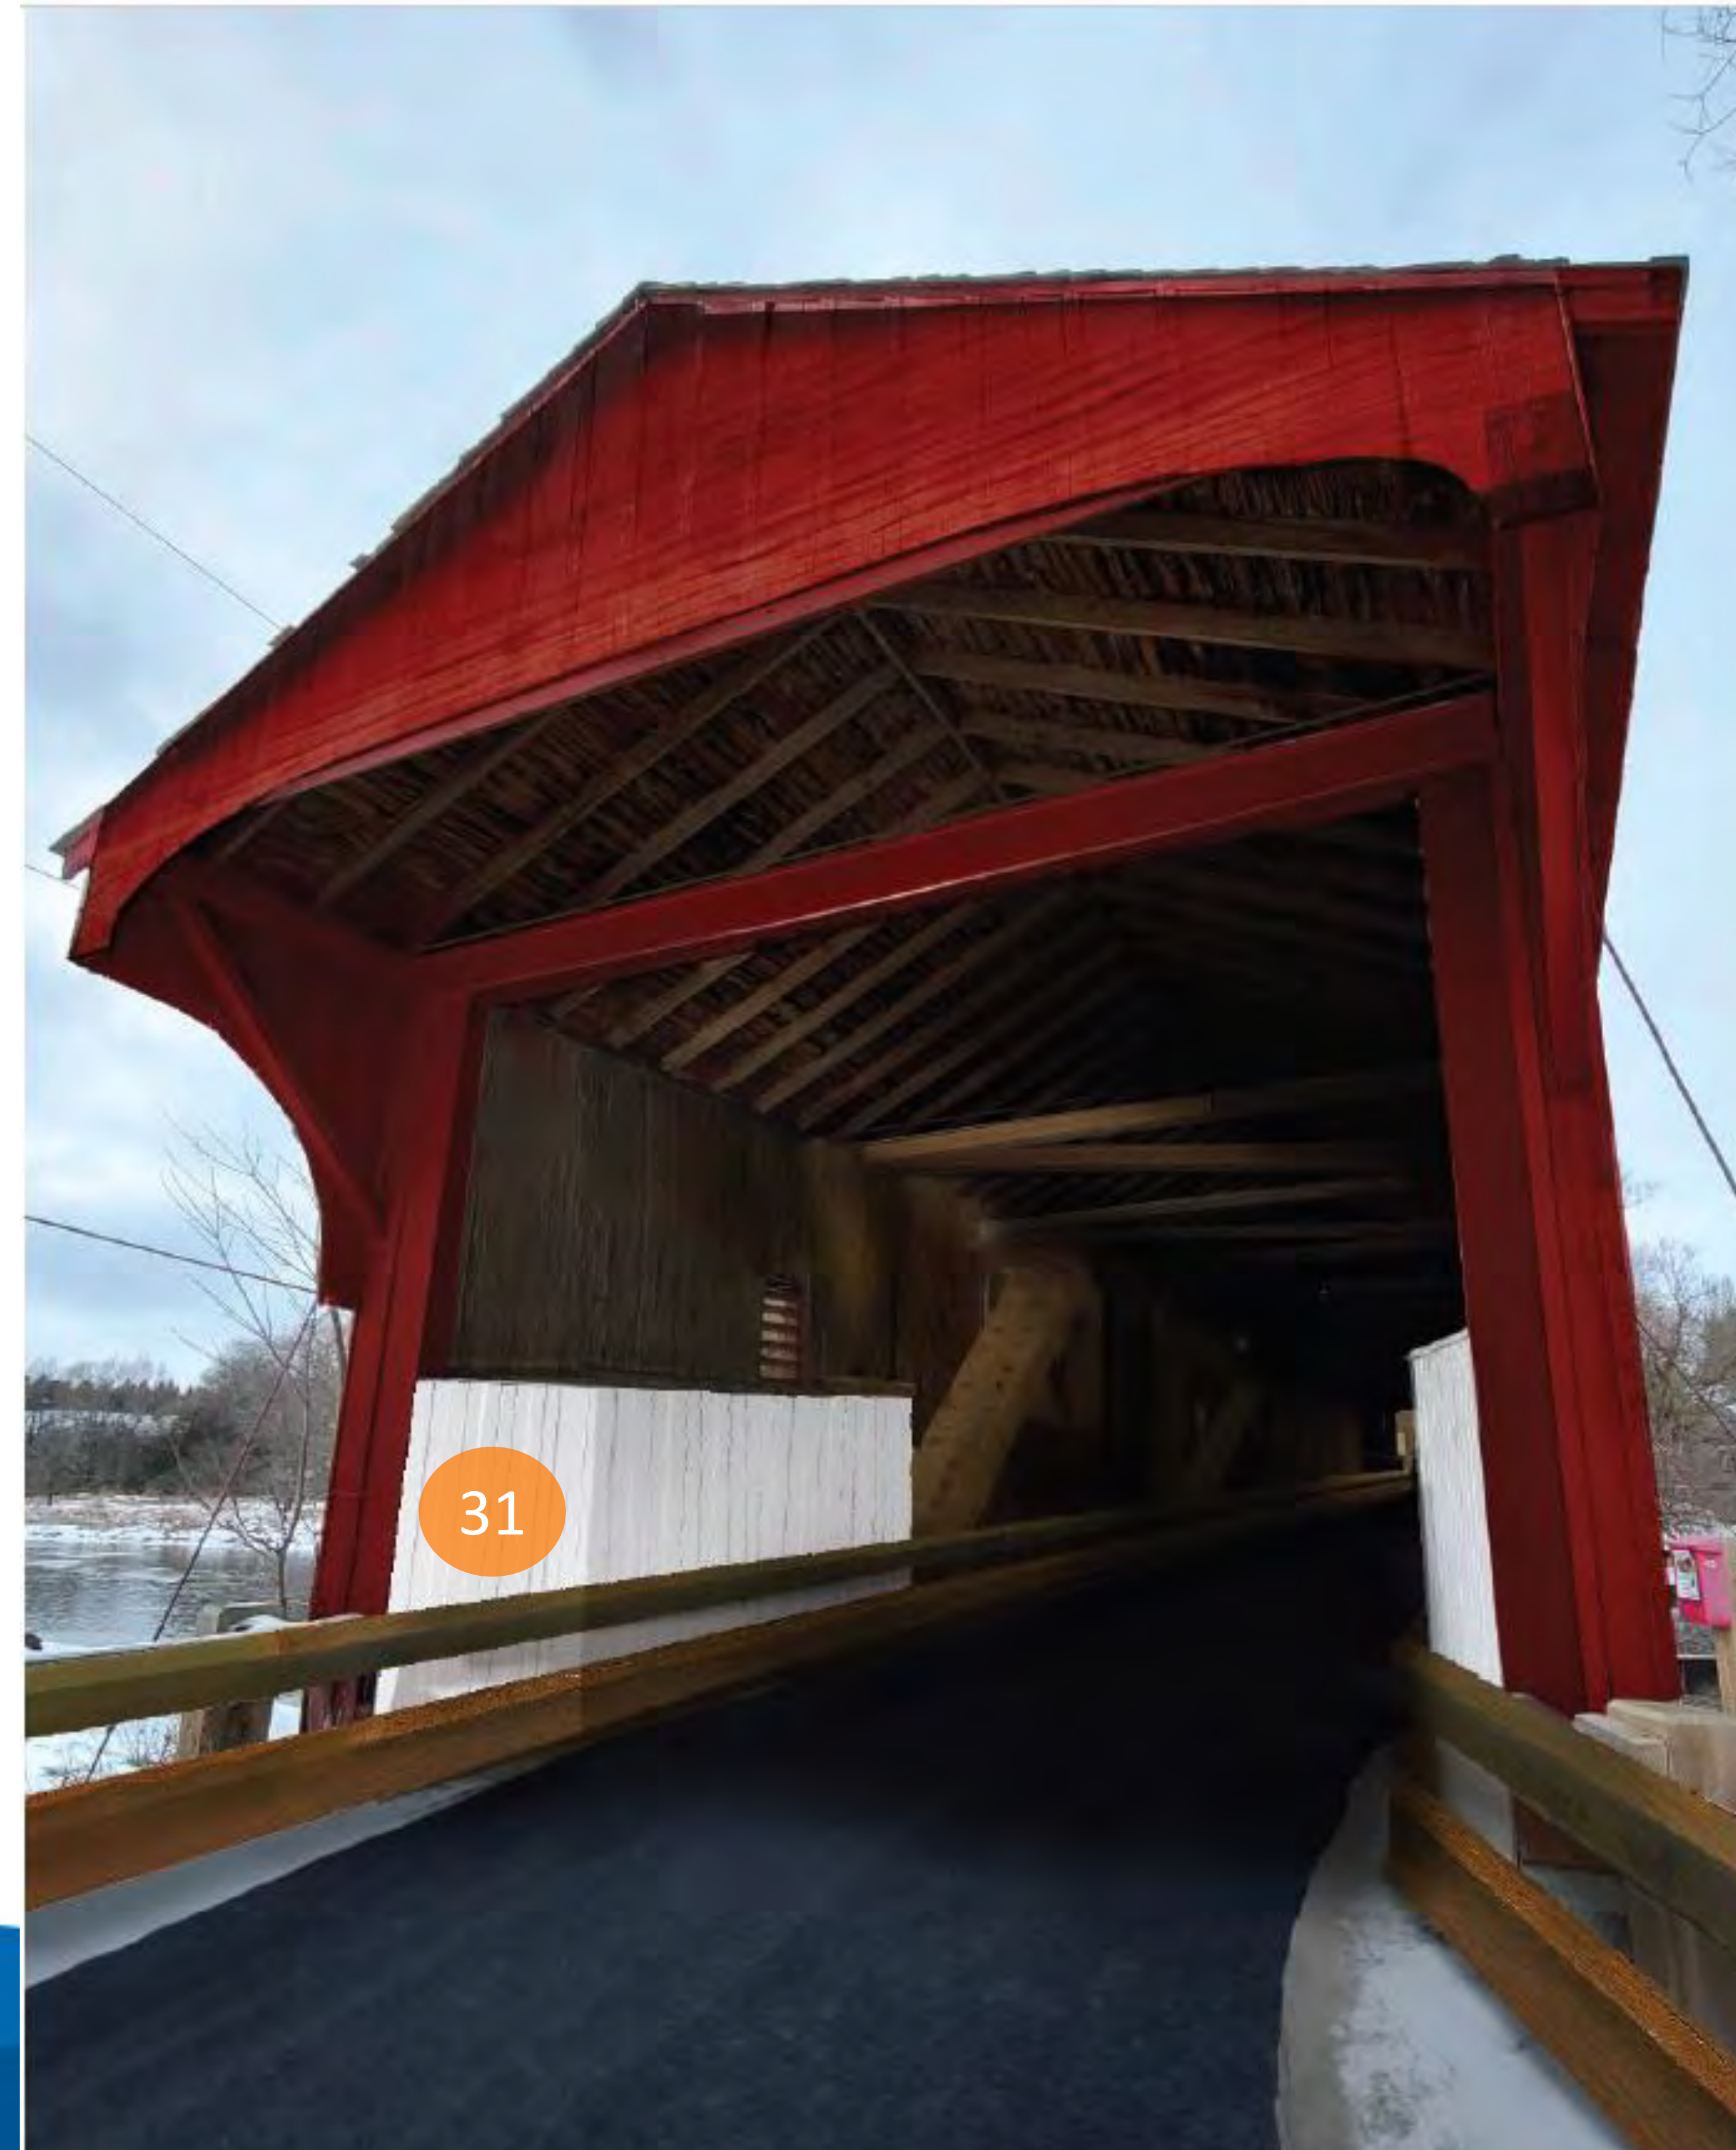
31 Reinstate interior cladding in short sections at each end of the bridge

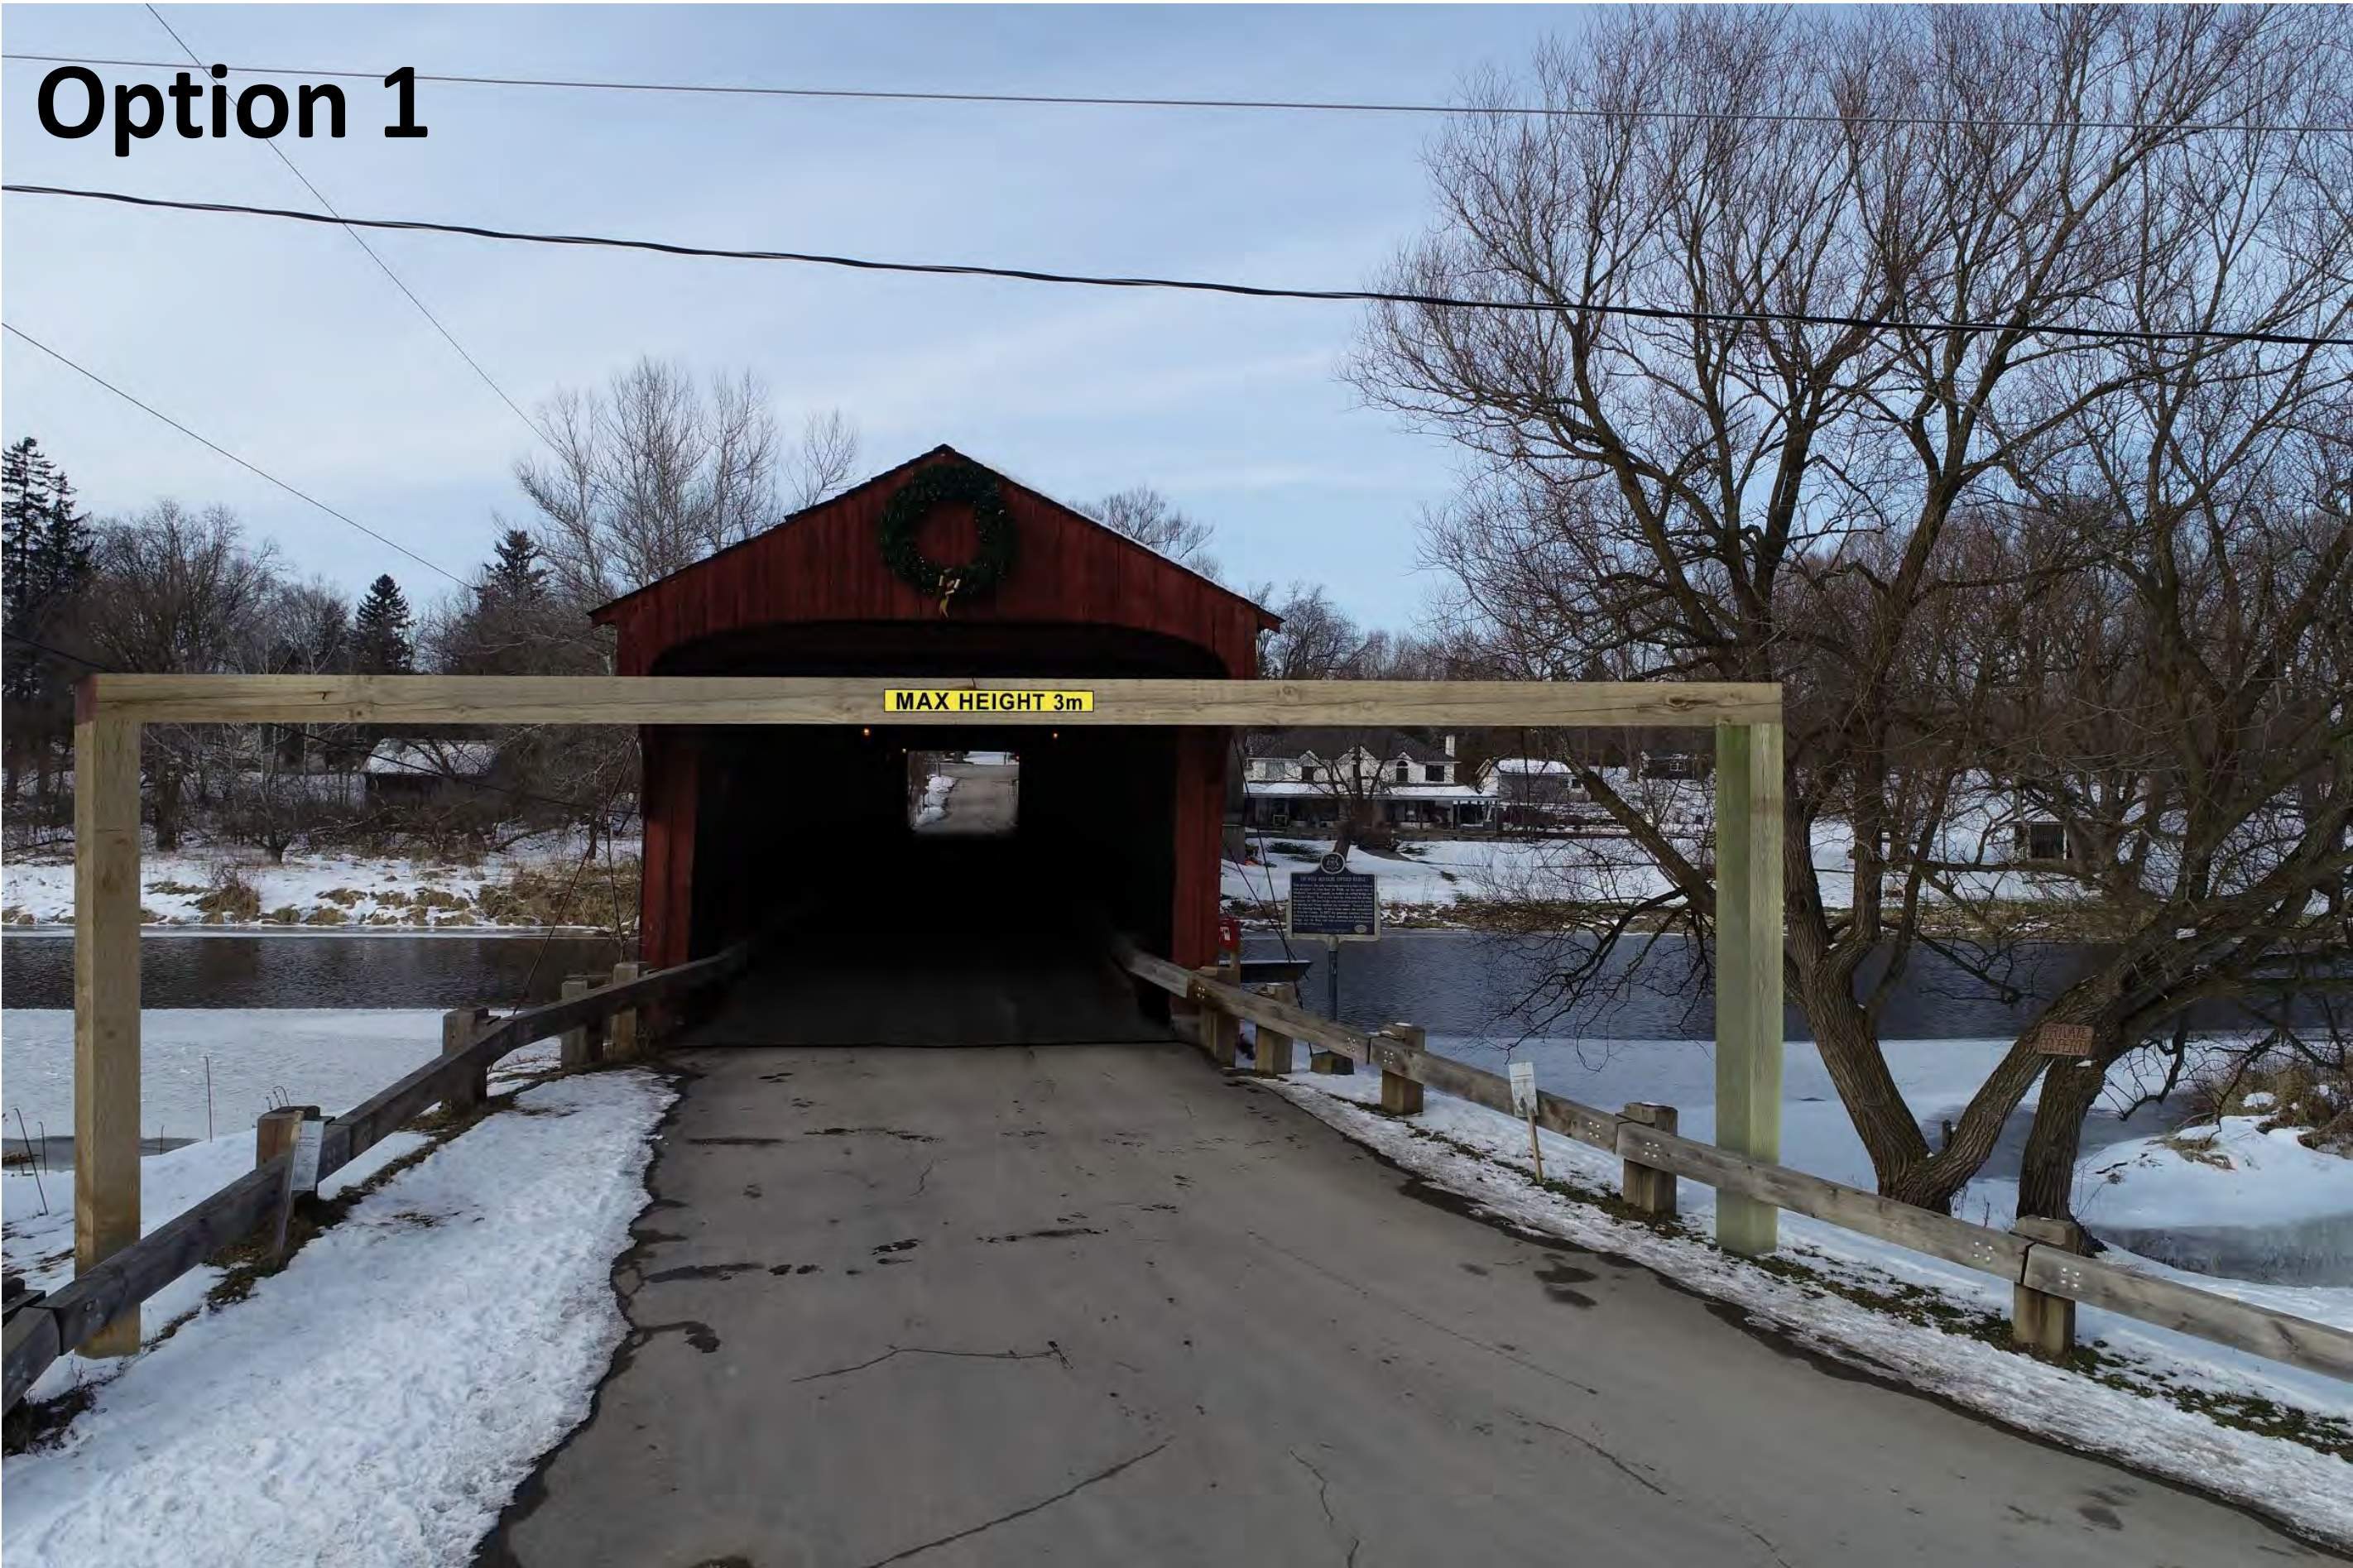
Option 1

Proposed Improvement #25 – Height Restrictor Bar Options for Public Input

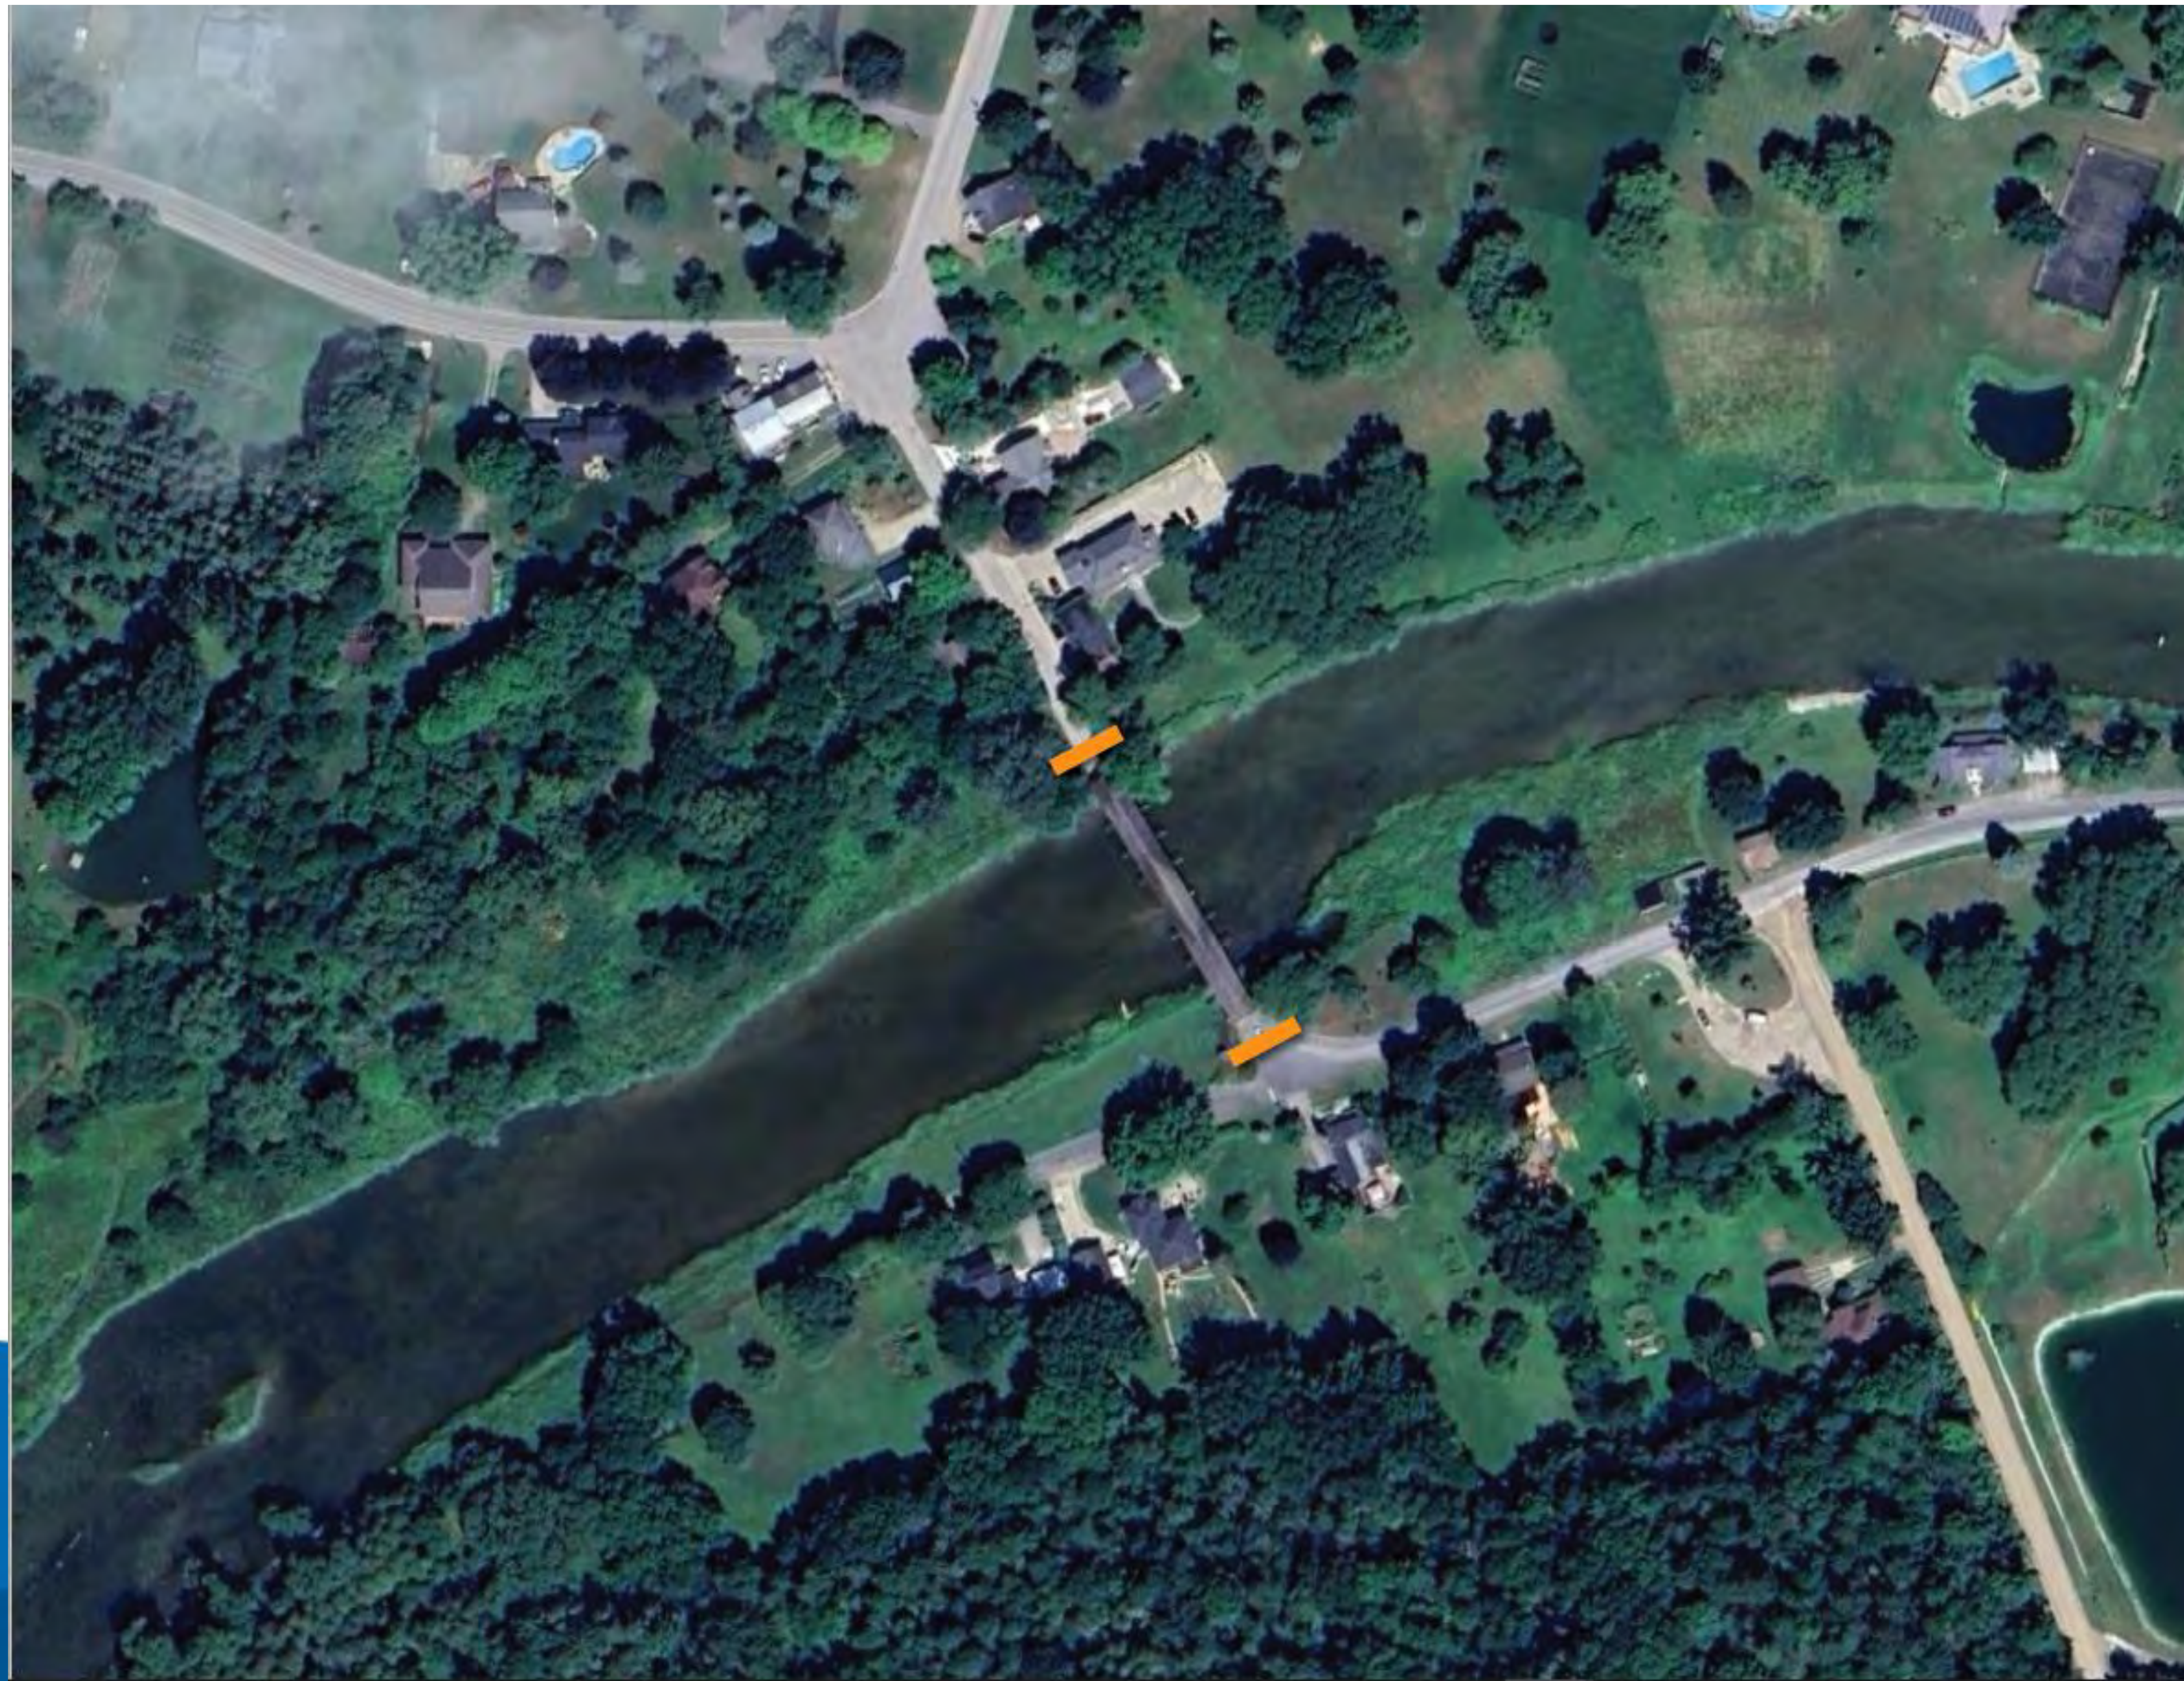
Proposed Location of Height Restrictor Bars
