Recommended Rehabilitation Alternative

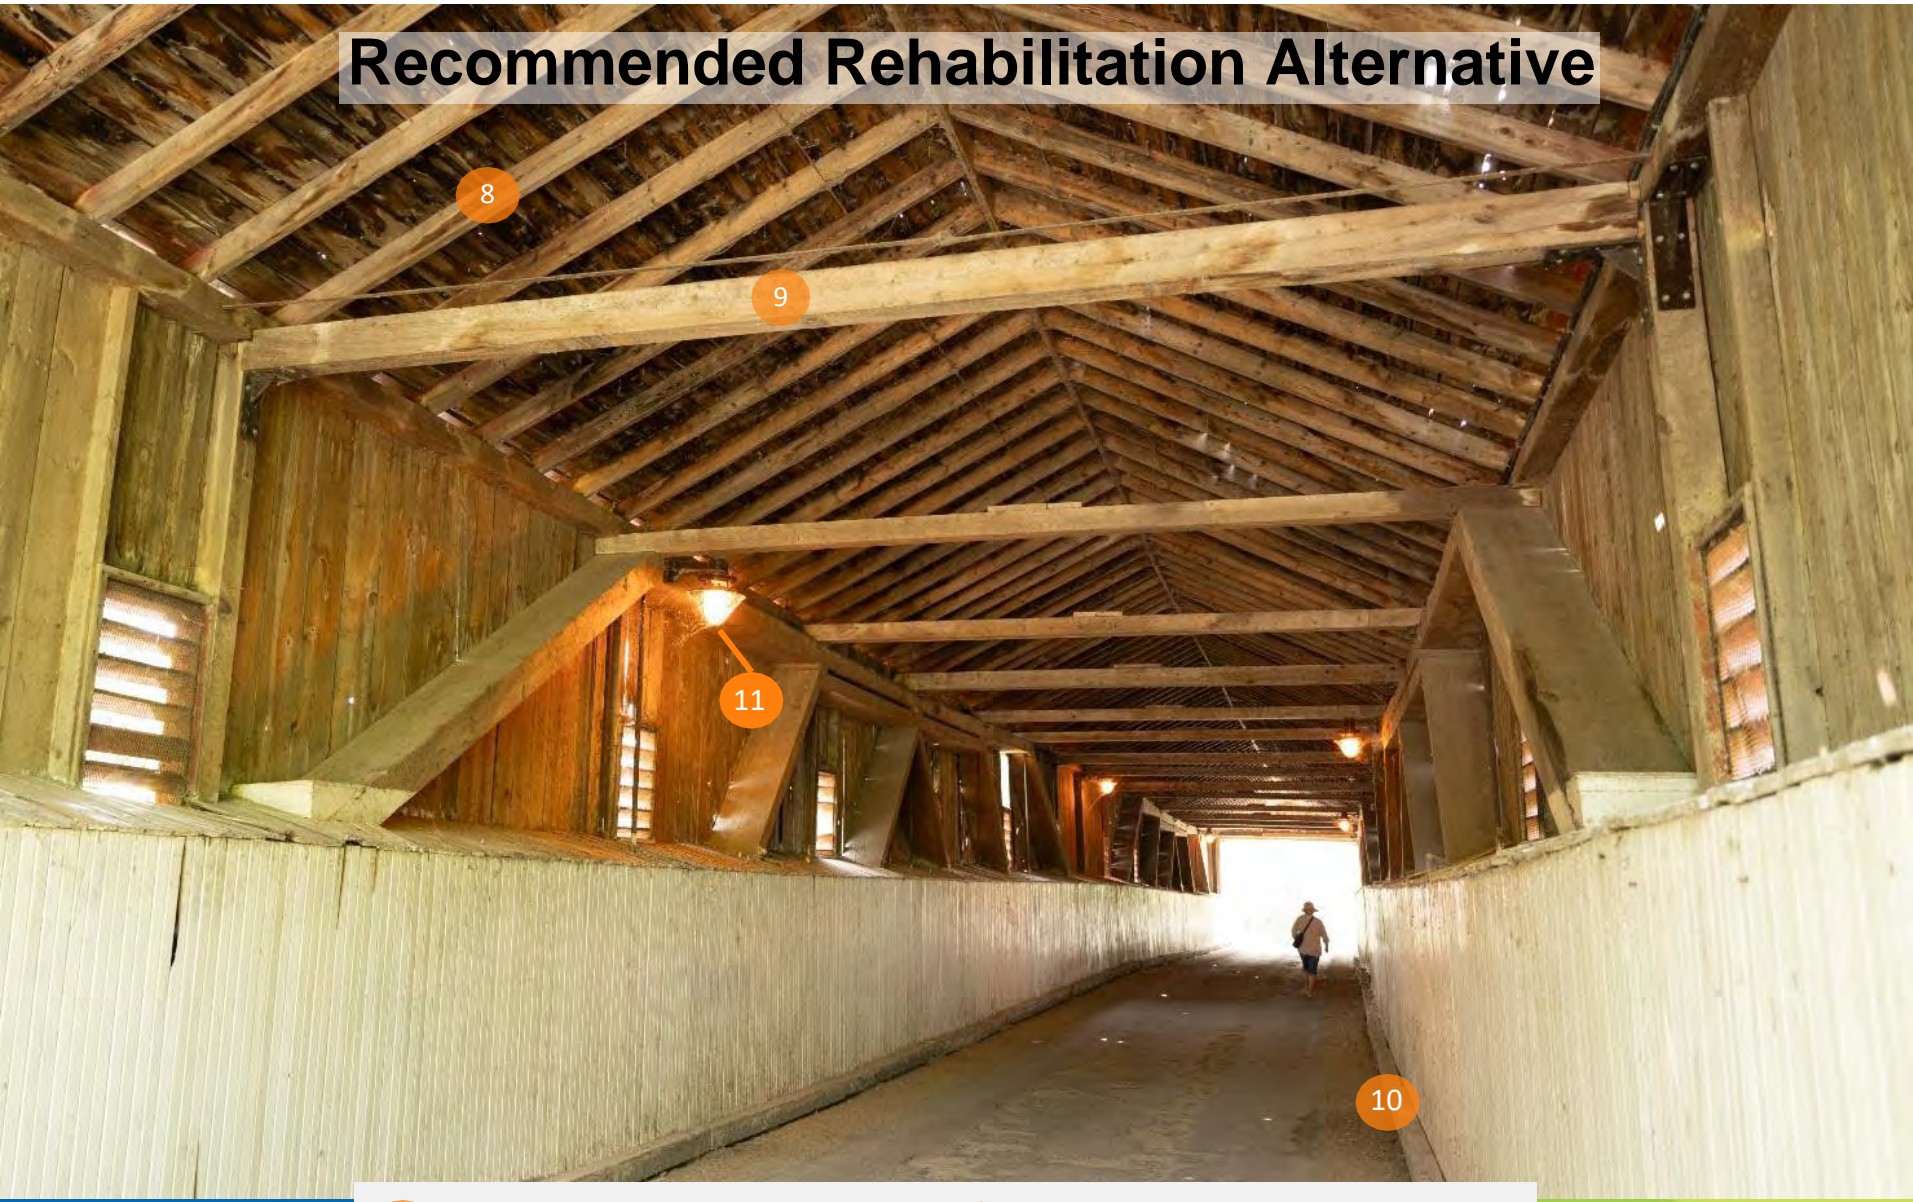
- 8 Replace rafters as necessary
- 9 Replace tie beams as necessary
- 10 Replace wood curbs
- 11 Replace light bulbs as necessary

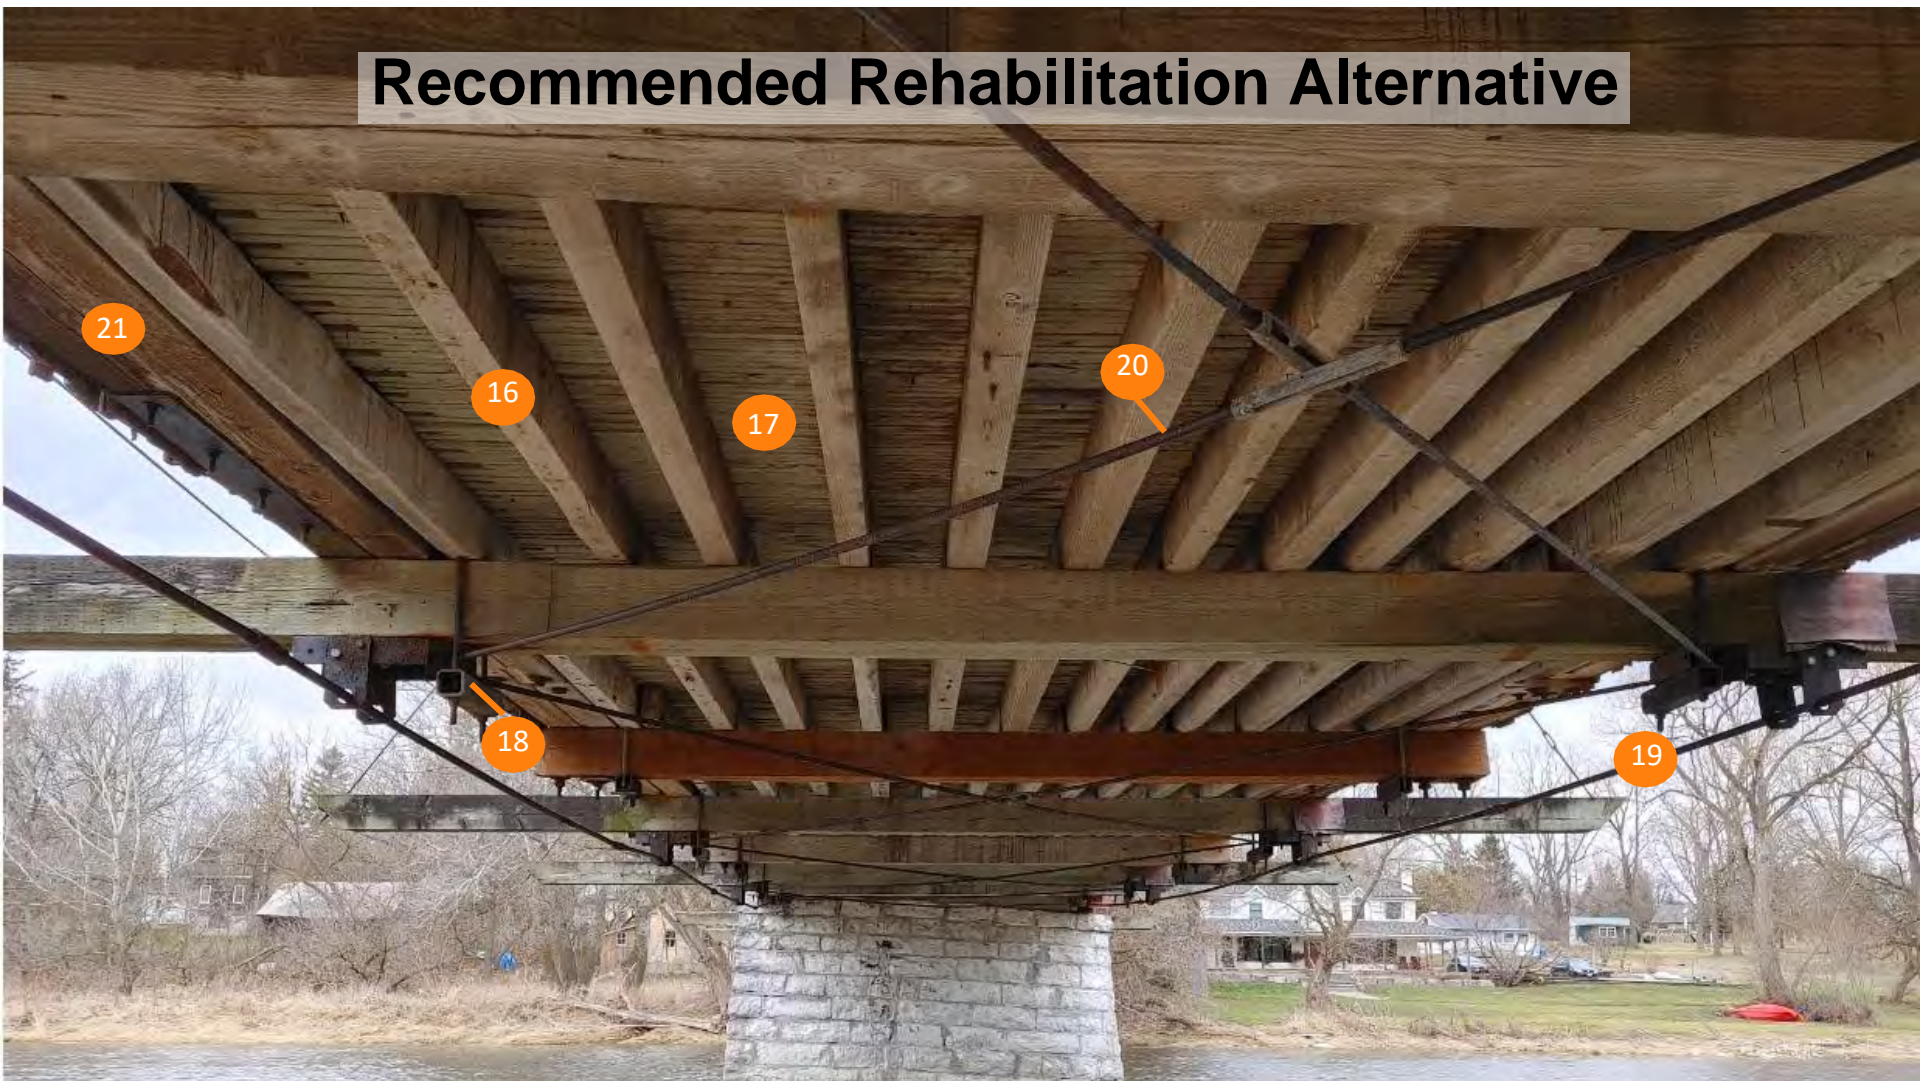
16 Replace stringers

17 Replace nail-laminated deck

18 Remove Bailey truss hanger system

19 Remove non-functioning tension rods (1959)

20 Replace bottom lateral bracing

21 Replace bottom chords

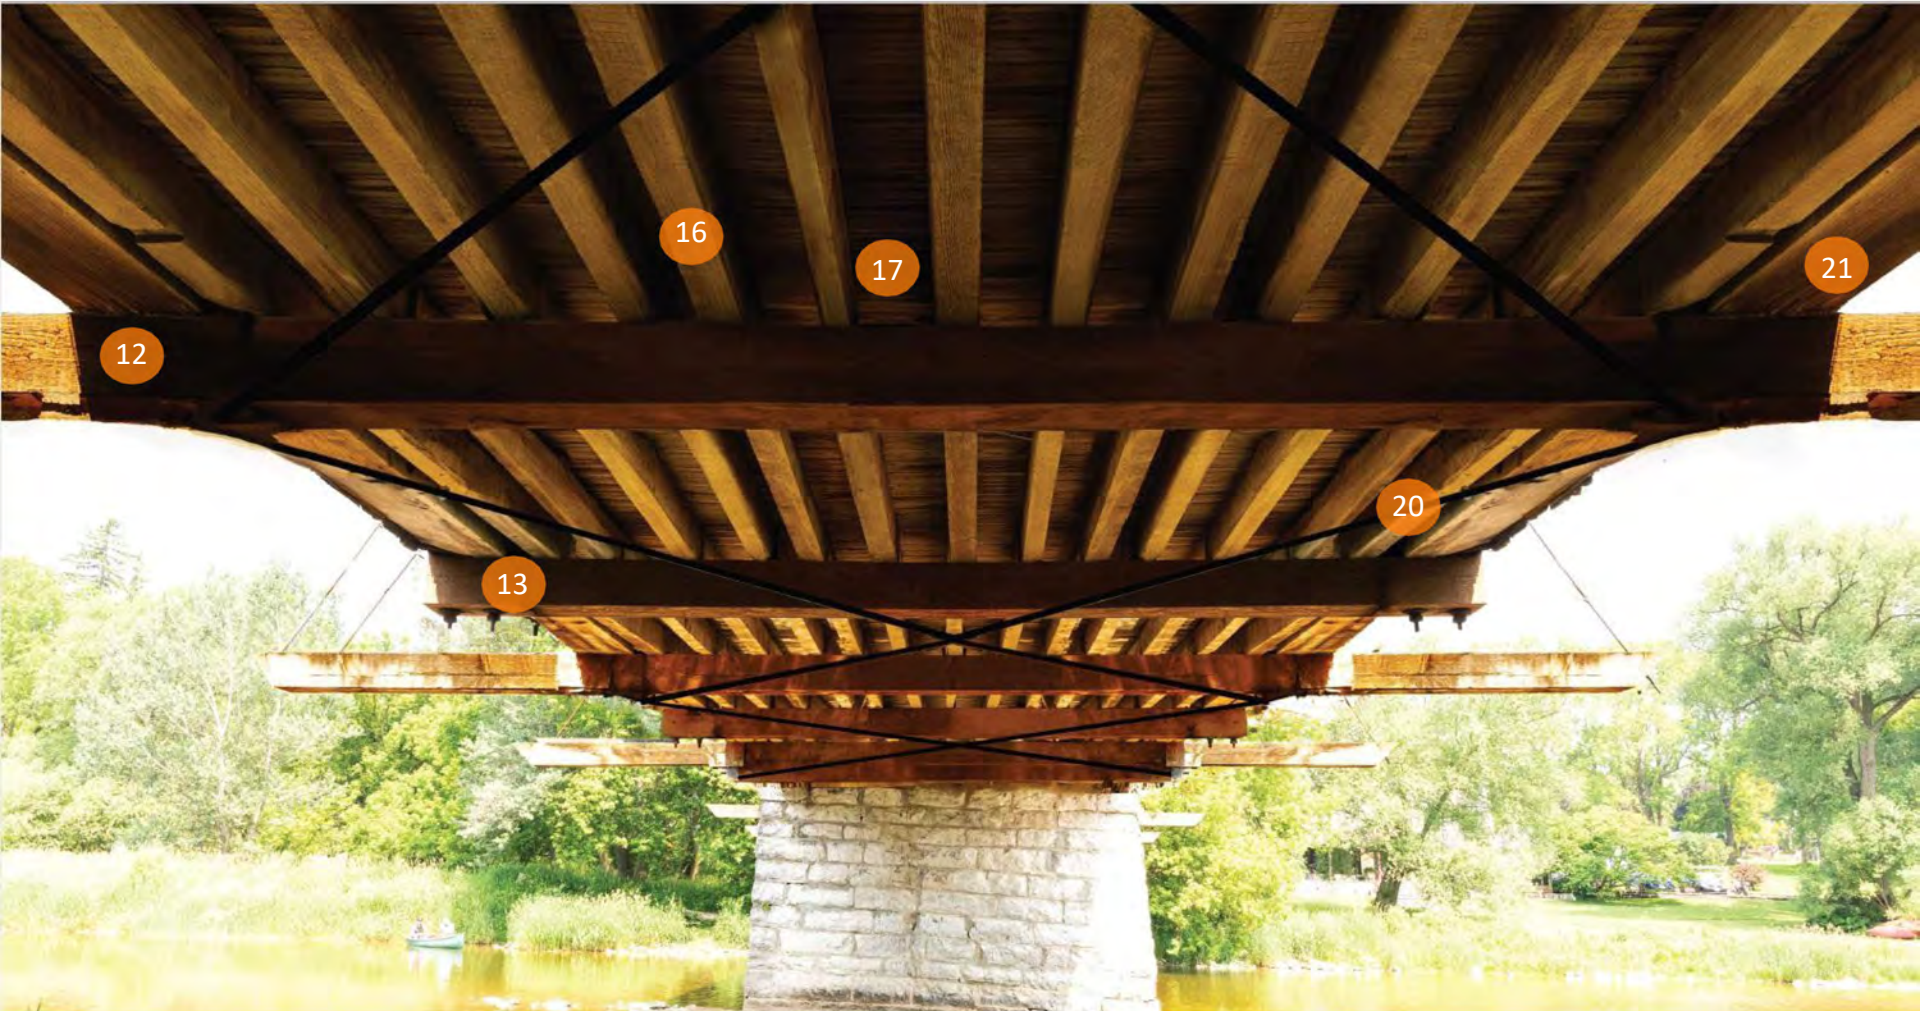
12 New Douglas Fir 16"x16" needle beams

13 New Douglas Fir 16"x16" floor beams

16 New sawn wood stringers

17 New nail-laminated wood deck
Page 140 of 147

20 New steel rod cross-bracing

21 New Douglas Fir bottom chords

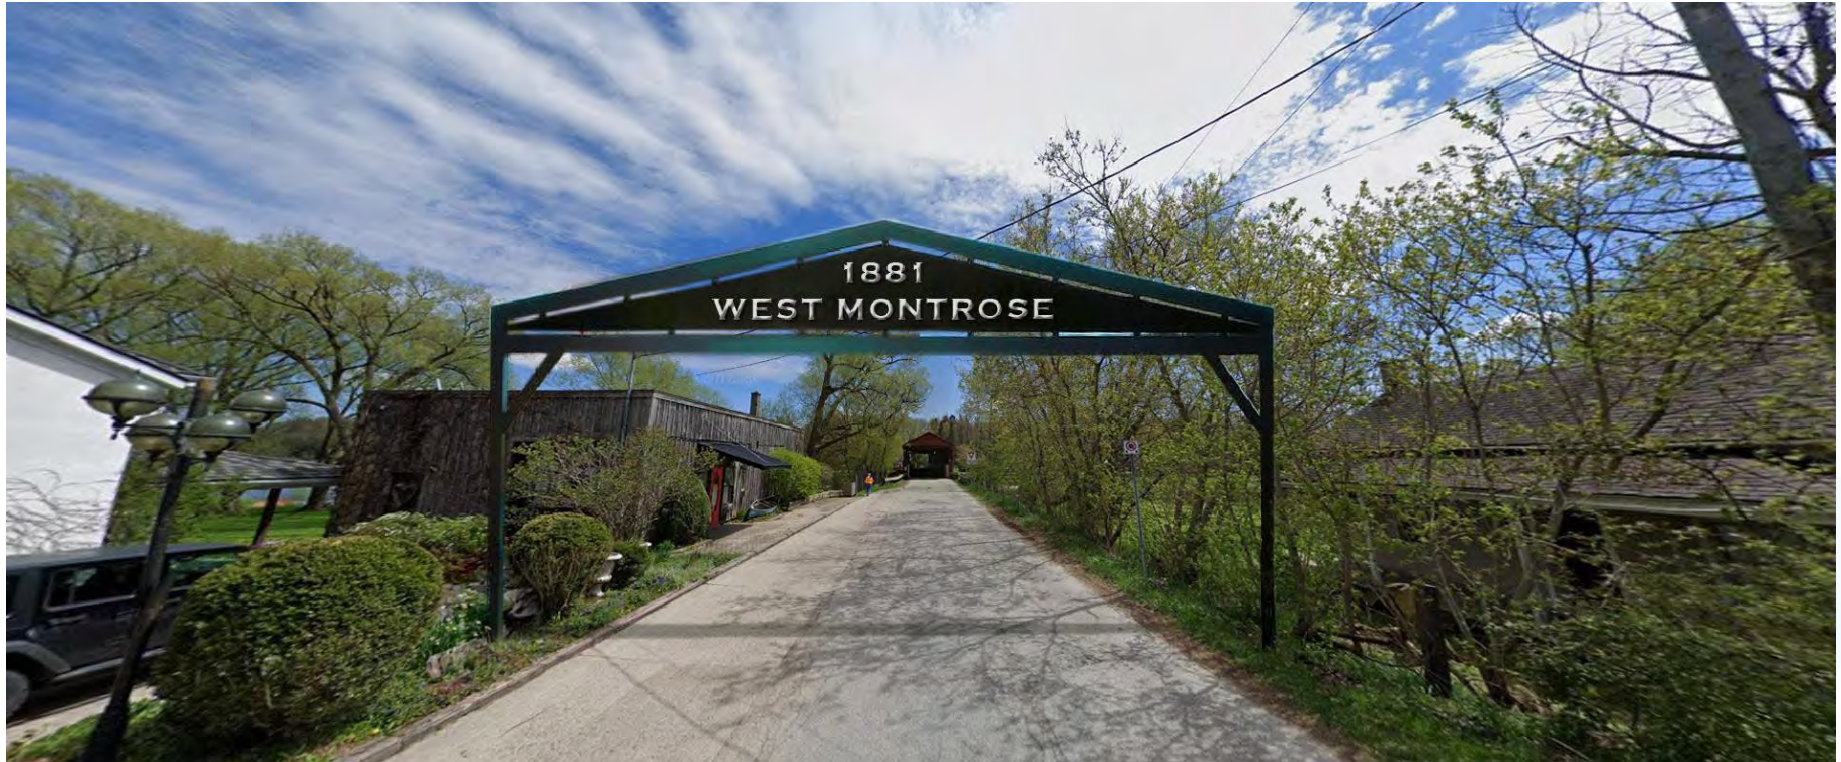
Height Restriction Bar - North Approach

*Details to be finalized with the input of an architect

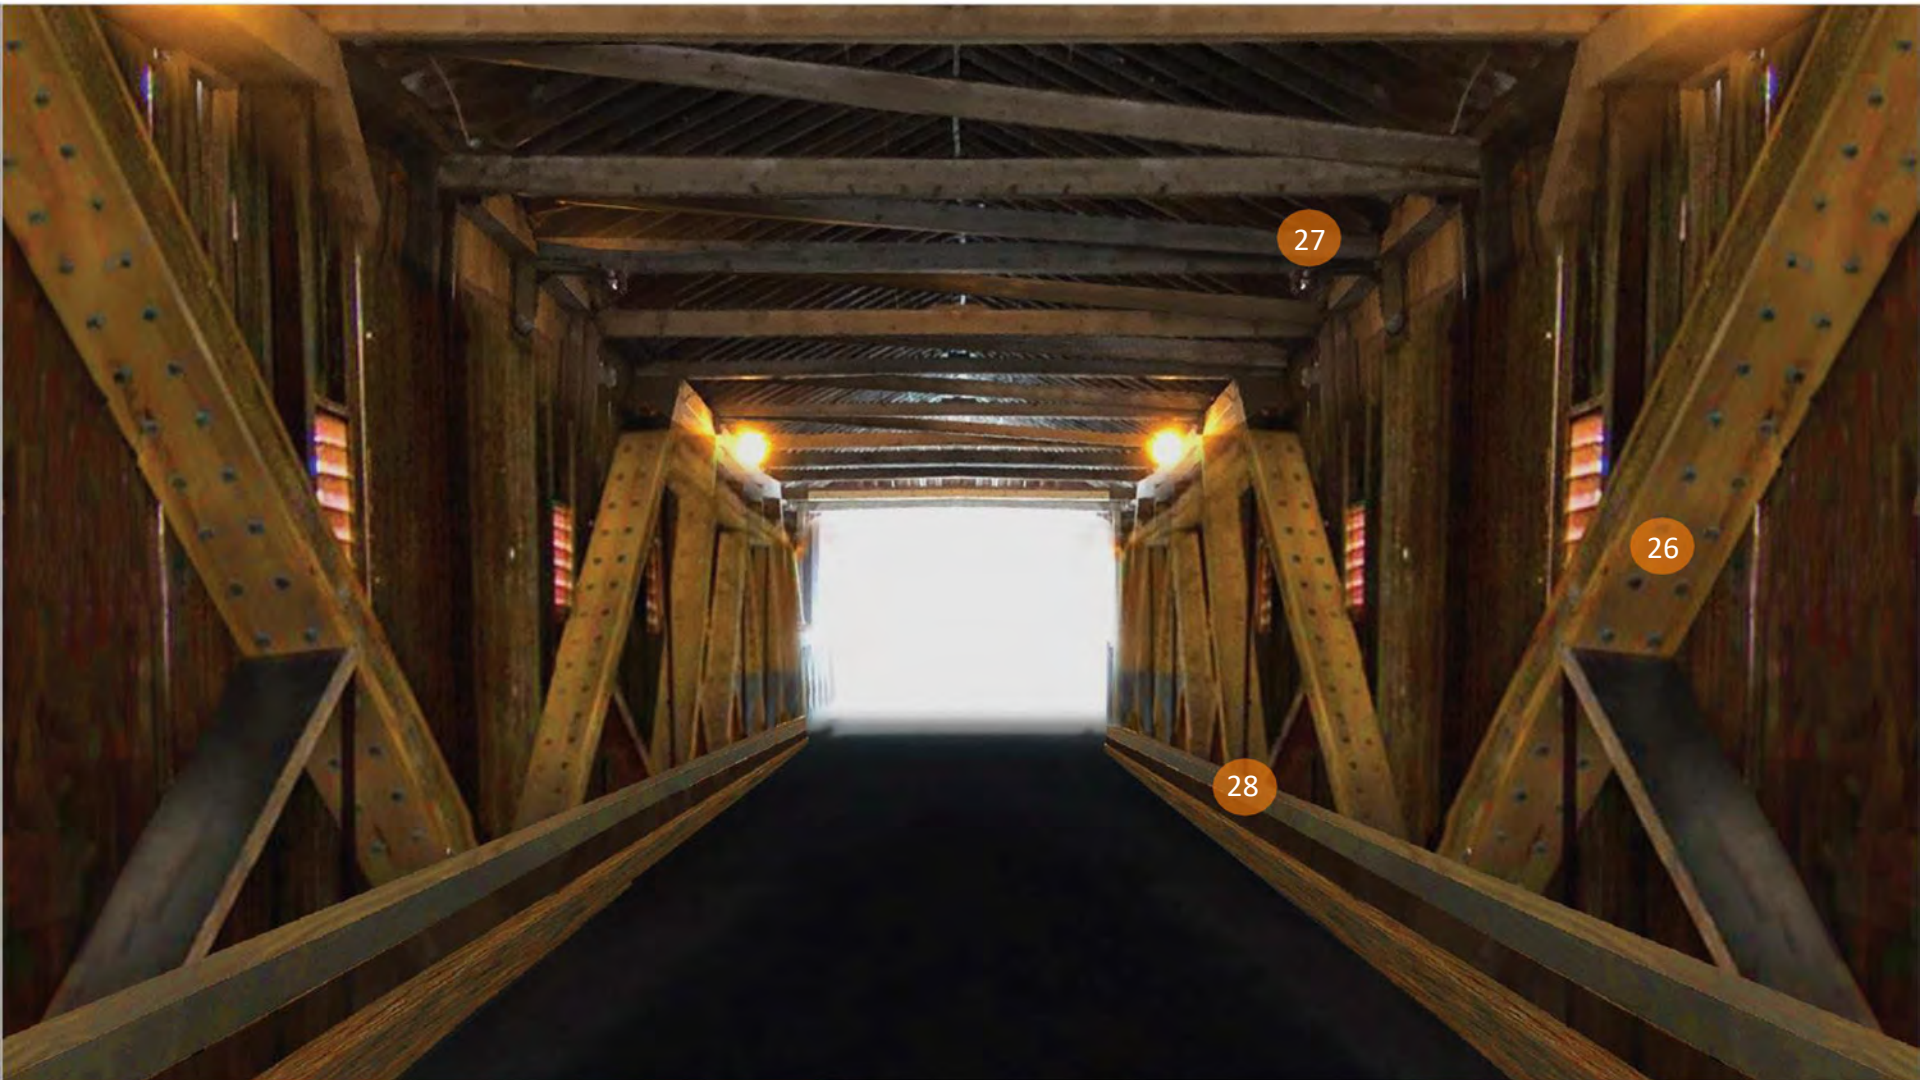
26 Replace end diagonals at pier and strengthen end diagonals at abutments

27 New overhead wood lateral bracing

28 New timber guiderail

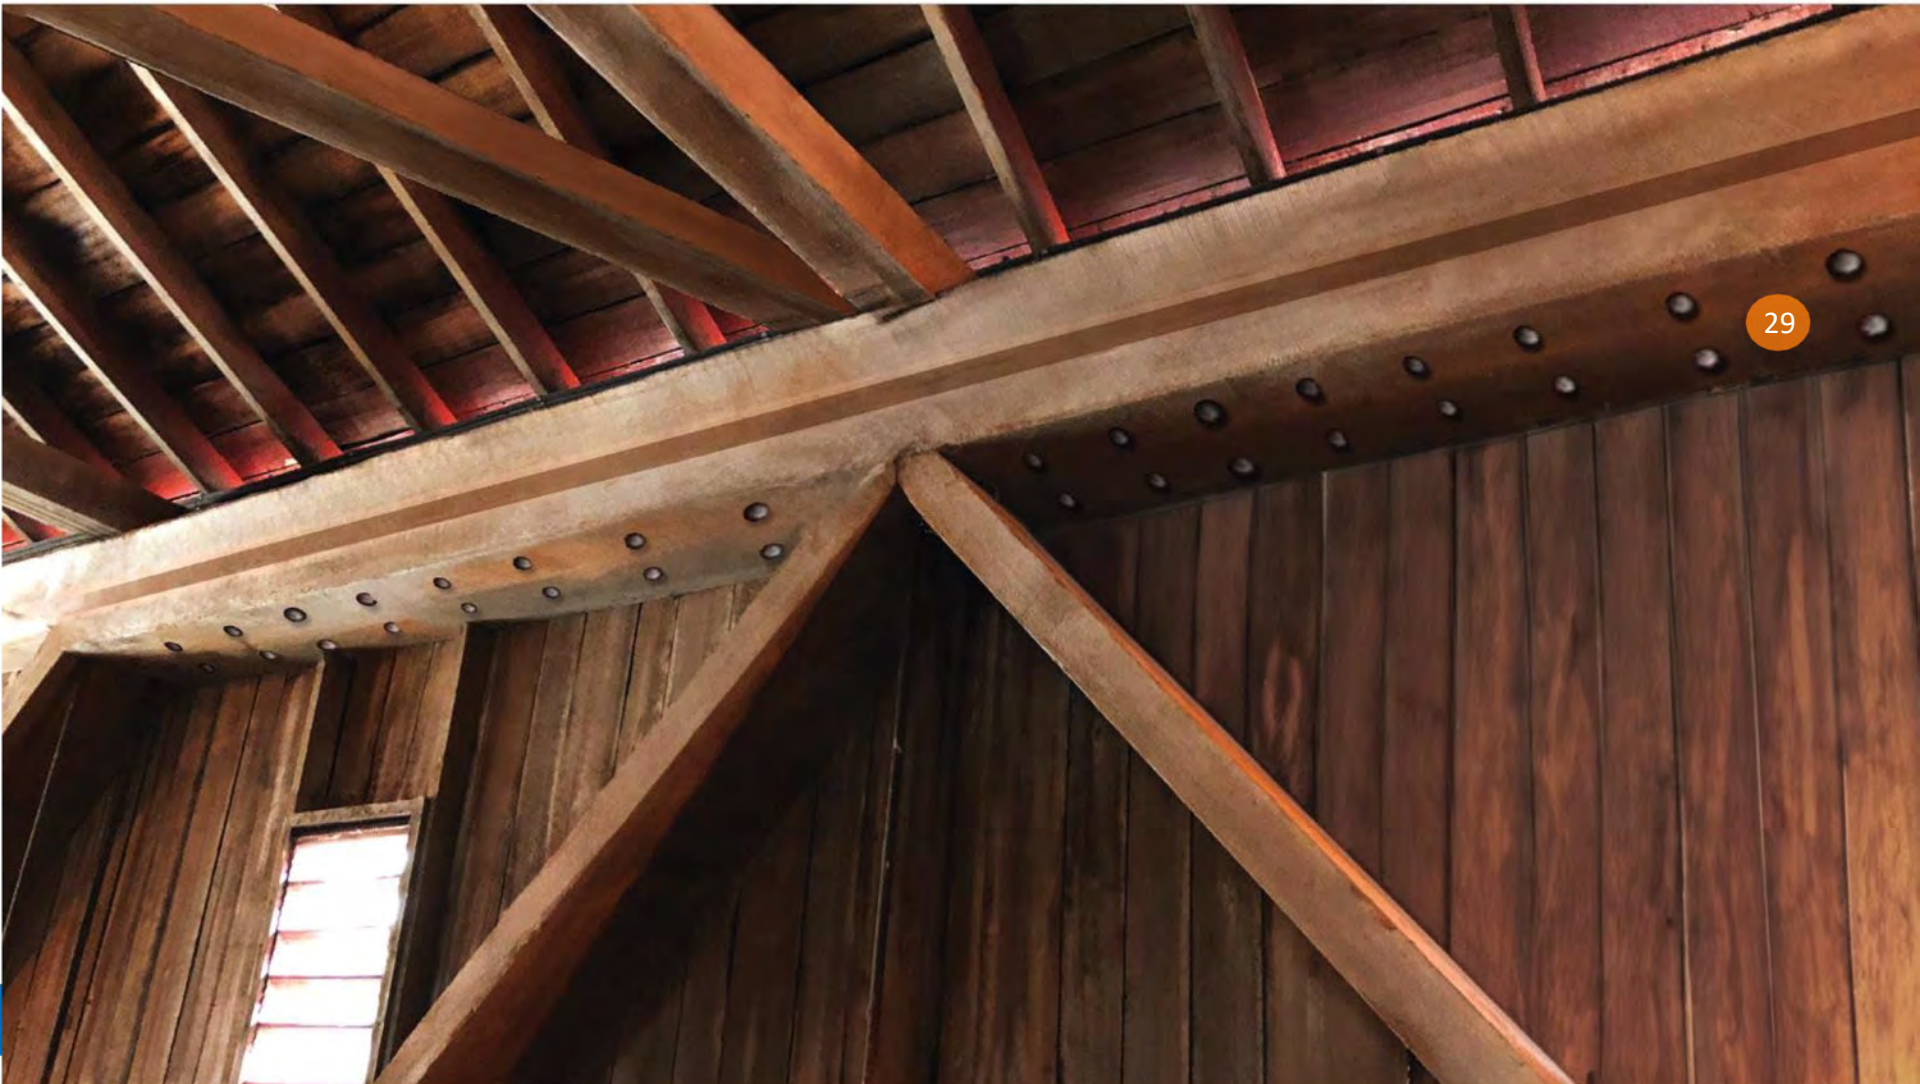
29 Reinforce top chord with lower top chord

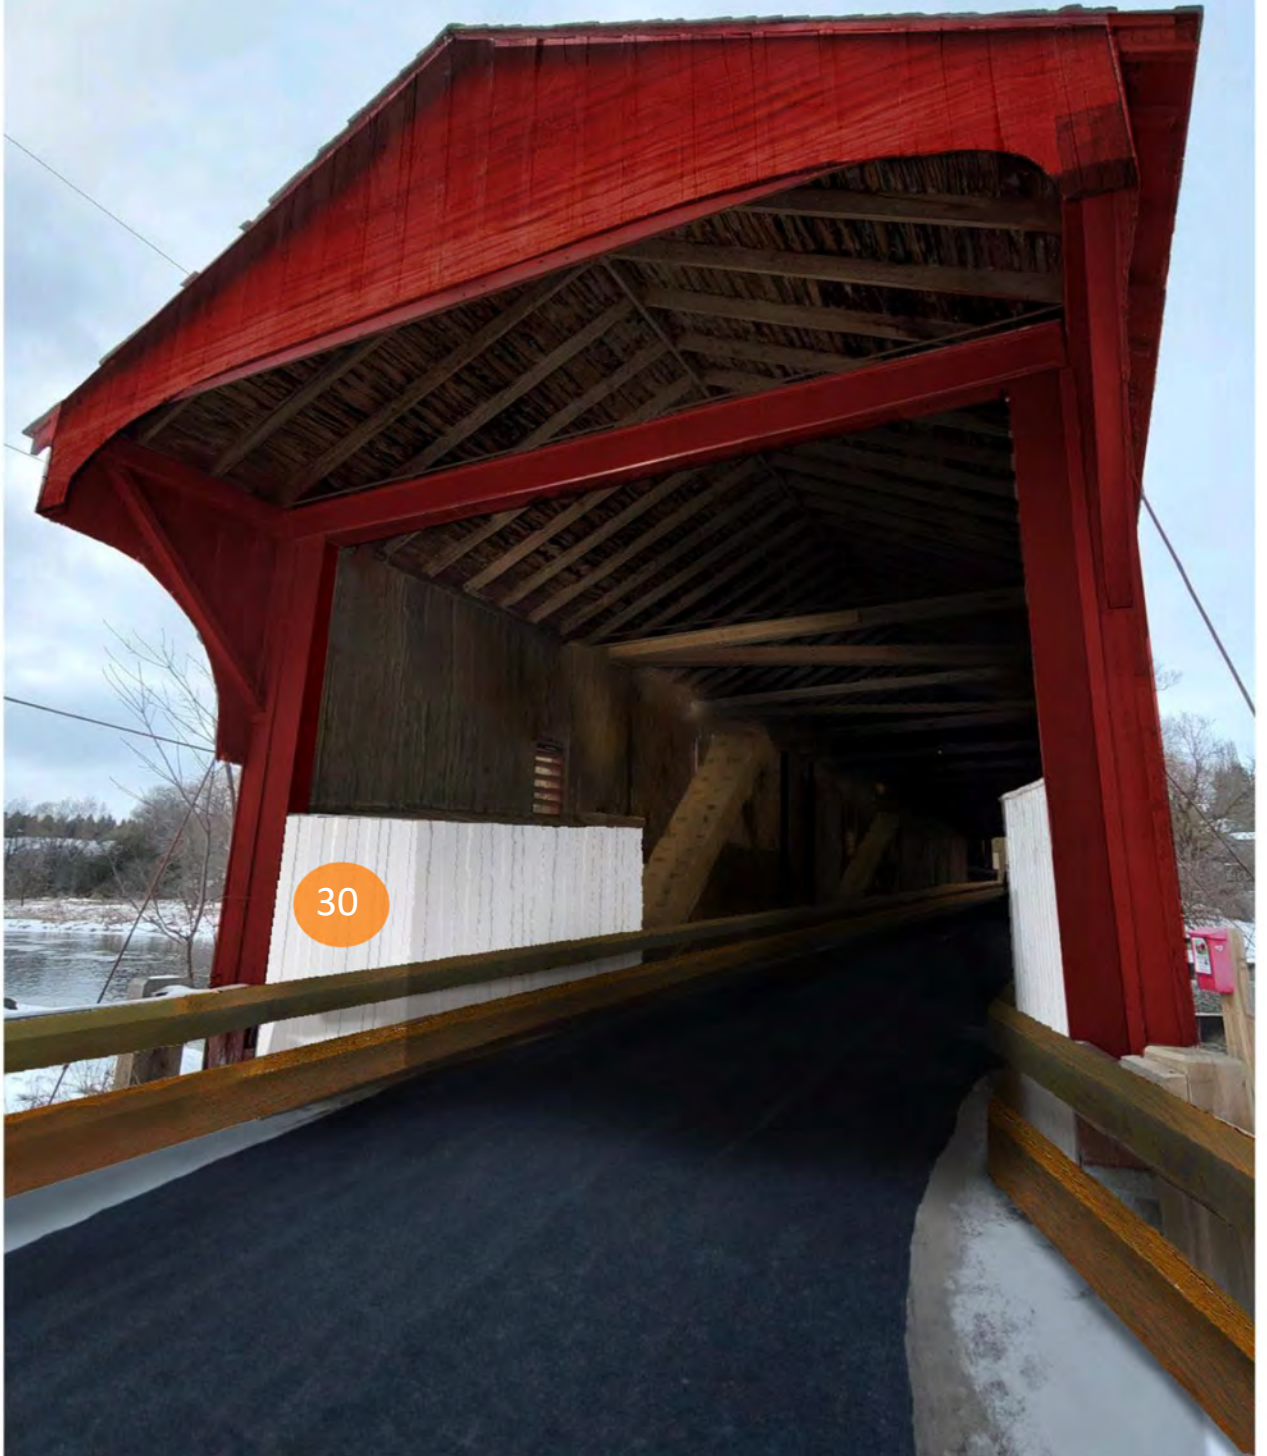
30

Reinstate interior cladding in short sections at each end of the bridge

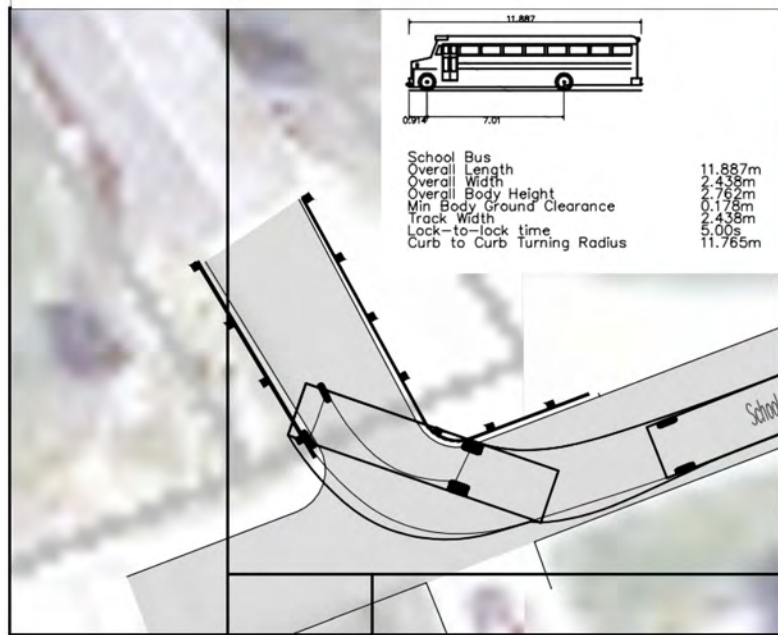
School Bus is Unable to Make a Turn onto the Bridge

School Bus	
Overall Length	11.887m
Overall Width	2.438m
Overall Body Height	2.762m
Min Body Ground Clearance	0.178m
Track Width	2.438m
Lock-to-lock time	5.00s
Curb to Curb Turning Radius	11.765m
